- Department of Environment and Conservation staff monitors the real-time web pages consistently.
- This monthly deployment report interprets the data from Rattling Brook Big Pond, Rattling Brook below Bridge and Rattling Brook below Plant Discharge stations for the period of November 18, 2009 to December 15, 2009.

### *RATTLING BROOK BIG POND*

*RATTLING BROOK BELOW BRIDGE*

### RATTLING BROOK BELOW PLANT DISCHARGE

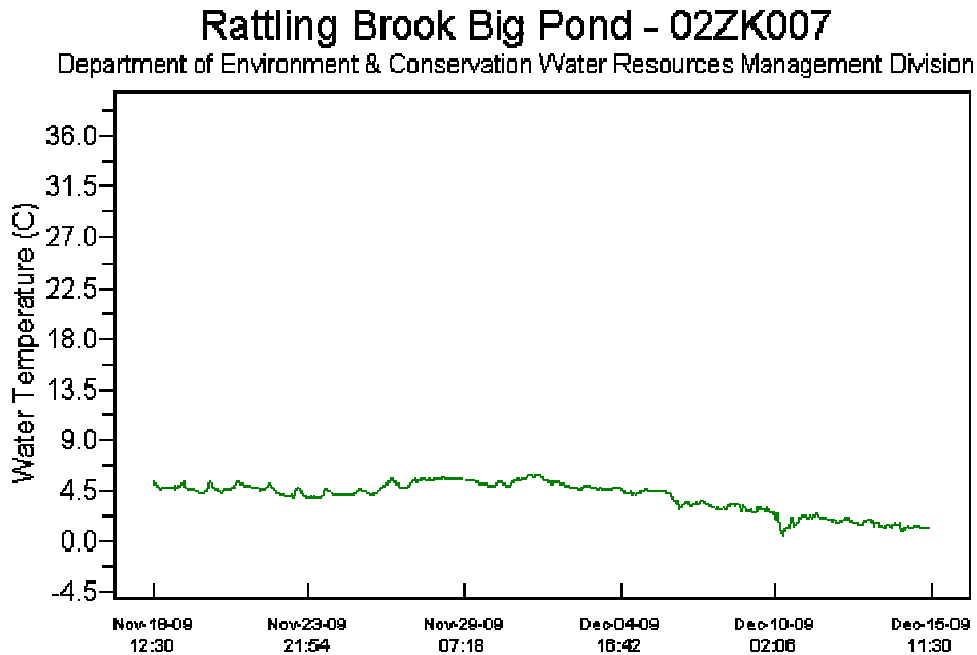
**Figure 1: Water Temperature at Rattling Brook Big Pond**

- Water temperature at Rattling Brook Big Pond followed expected trends and declined to a low of 0.48°C. The maximum temperature was 5.87°C.

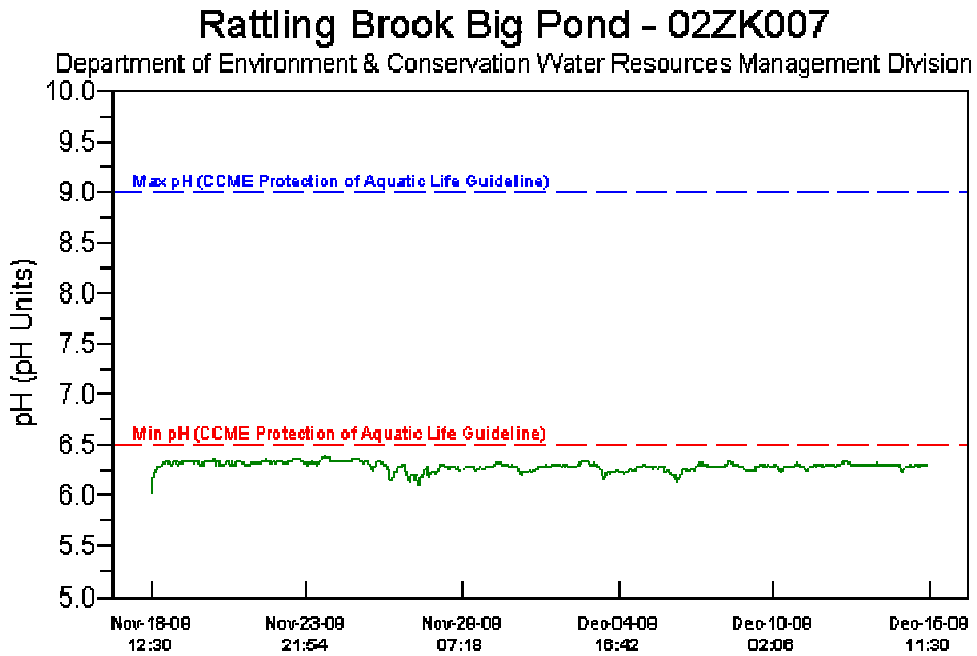
Figure 2: pH at Rattling Brook Big Pond

- pH was stable with no noticeable trend upwards or down from November 18<sup>th</sup> to December 15<sup>th</sup>. The maximum pH occurred on November 24<sup>th</sup> (6.38) and the minimum occurred on November 27<sup>th</sup> (6.10). Despite the fact that the pH values were below the minimum pH for the protection of aquatic life as stated by the CCME, no concern is warranted as this is likely the natural condition of pH in this river system.

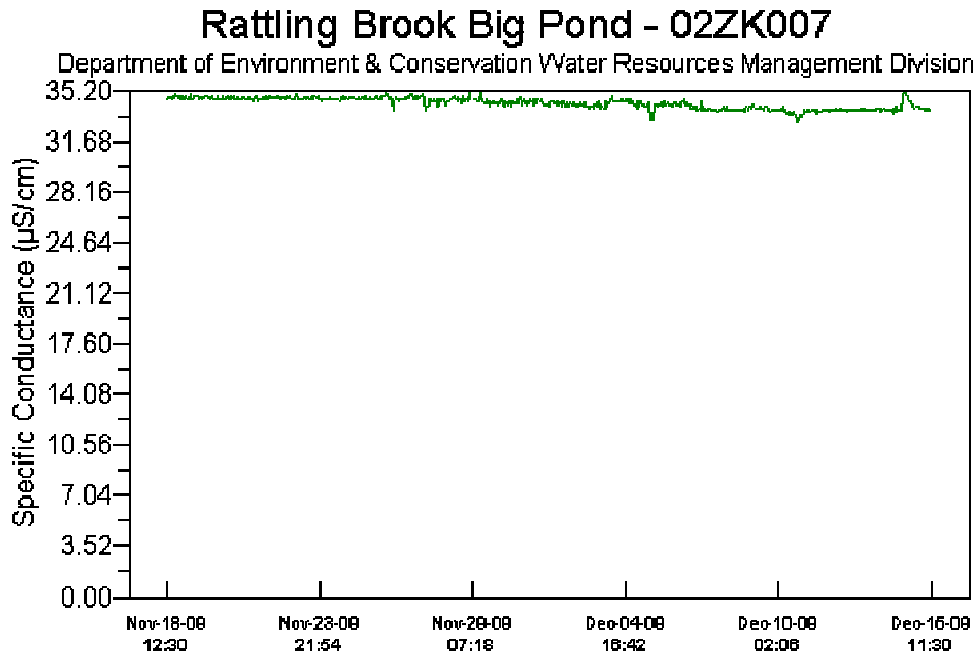
Figure 3: Specific Conductivity at Rattling Brook Big Pond

- Specific Conductivity ranged from 33.0 to 35.2  $\mu\text{S}/\text{cm}$ . A slight downward trend is seen in the figure over the course of the deployment period. This is likely due to calibration and/or fouling of the sensor. No concern is warranted.

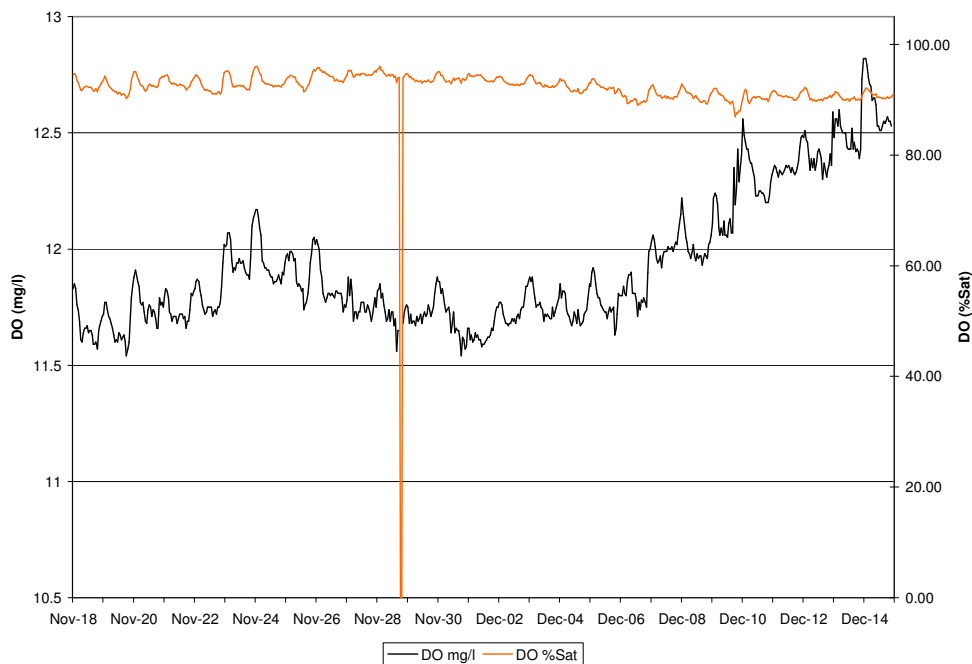
Figure 4: Dissolved Oxygen at Rattling Brook Big Pond

- Dissolved oxygen in Big Pond tends to be slightly lower than at stations further down in the Rattling Brook system (below Bridge and below Plant Discharge). This is likely due to the relatively still waters in Big

Pond as opposed to Rattling Brook, where flowing riffles and rapids increase the content of dissolved oxygen. Regardless of the slightly lower concentration of DO in Big Pond, the concentration of DO at Big Pond ranged from 11.54 mg/l to 12.82 mg/l; all values were above the CCME guideline of 9.5 mg/l for the protection of early life-stage cold-water biota.

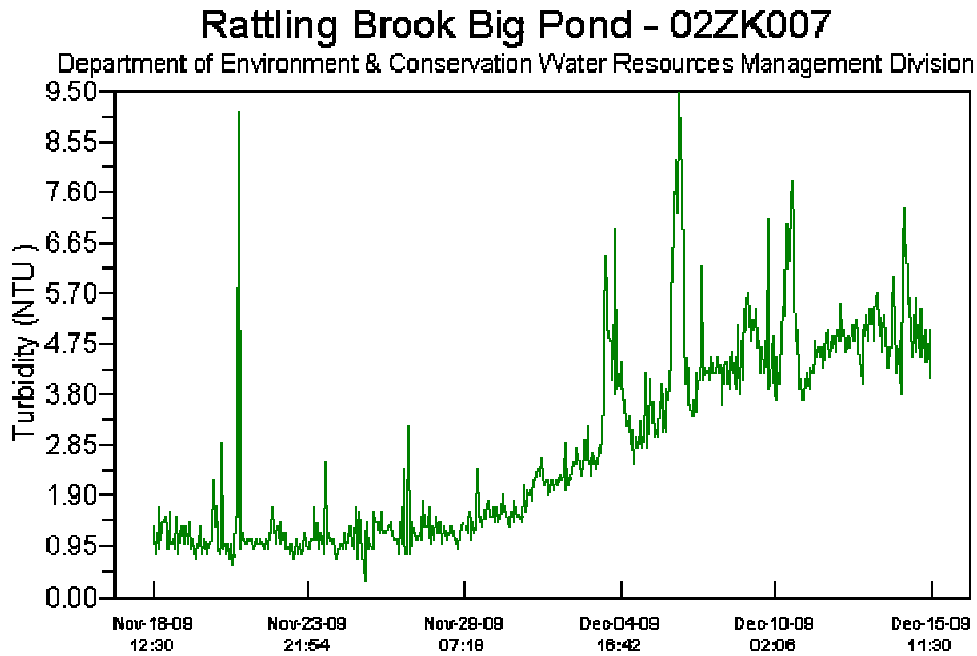
Figure 5: Turbidity at Rattling Brook Big Pond

- Wave action near the shore deployment of the water quality sonde results in increased turbidity readings at this station. Aside from the large spikes, the steady increase in turbidity in the second half of the deployment is not correlated with air temperature, wind, or precipitation. Because of this, it is possible that fouling from silt deposition caused drift in the sensor. The Water Resources Management Division will closely follow the trends at this station in the future to determine if a different deployment method is warranted.

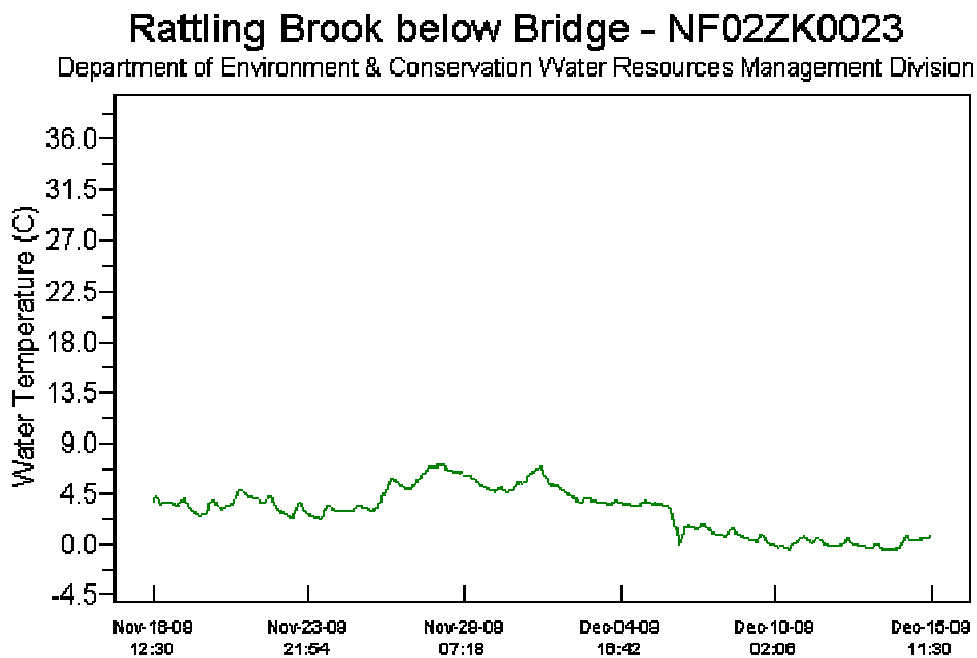
Figure 6: Water Temperature at Rattling Brook below Bridge

- Water temperature at Rattling Brook below Bridge (Bridge) declines as expected over the deployment period from a high of 7.01°C to a low of -0.5°C.

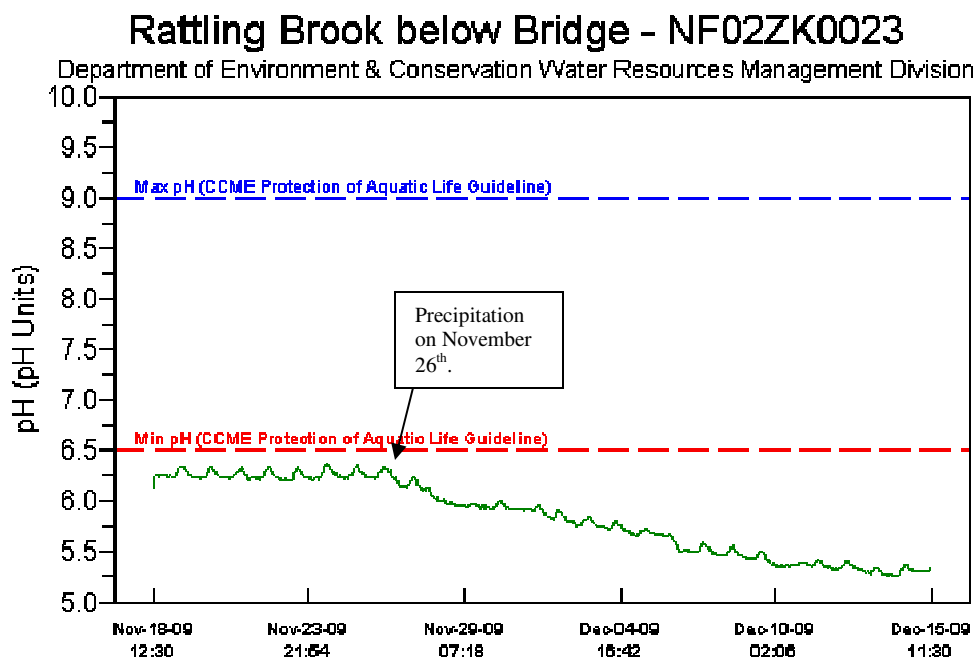
Figure 7: pH at Rattling Brook below Bridge

- The first 1/3 of the deployment period appears stable and level followed by a notable decline. This decline occurs during a period of high flow about 15 mm on November 26<sup>th</sup>. Interestingly, pH does not recover after

the precipitation. It is possible that some material may have deposited itself on the pH sensor or calibration drift occurred.

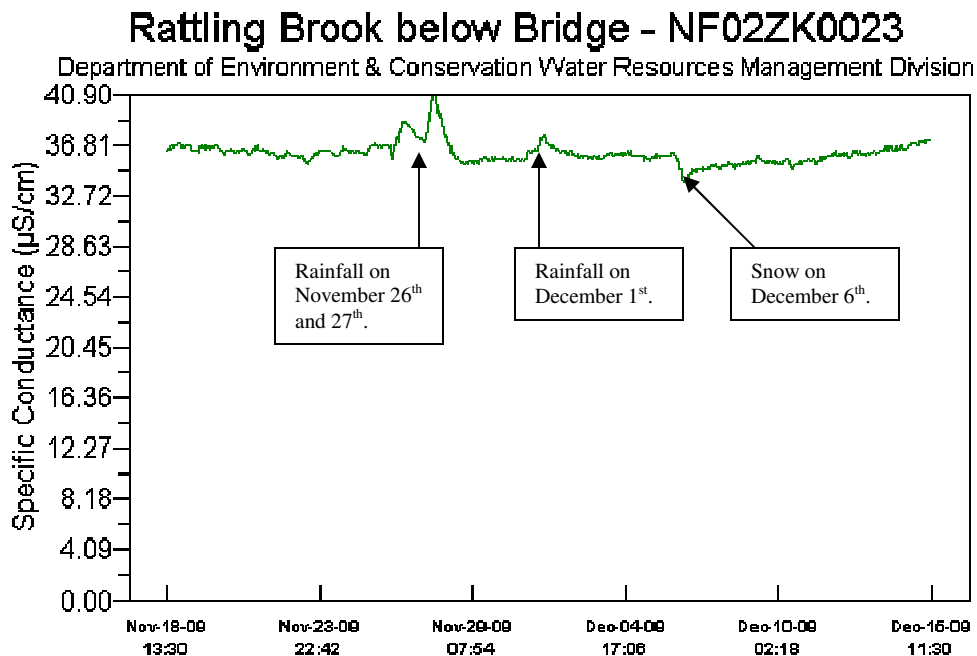
Figure 8: Specific Conductivity at Rattling Brook below Bridge

- Conductivity at Rattling Brook below Bridge ranged from 33.9 to 40.9  $\mu\text{S}/\text{cm}$  during the deployment period. Two peaks indicated on the graph above are associated with heavy precipitation of about 42 mm on November 26<sup>th</sup> and 27<sup>th</sup>, and 26 mm on December 1<sup>st</sup> resulting in runoff into the river system. Another precipitation event on December 6<sup>th</sup> caused a decline in conductivity as opposed to a spike due to air temperature at the time. Precipitation between December 5<sup>th</sup> and 9<sup>th</sup> fell as snow, causing little to no runoff, leading to a dilution effect in the river.

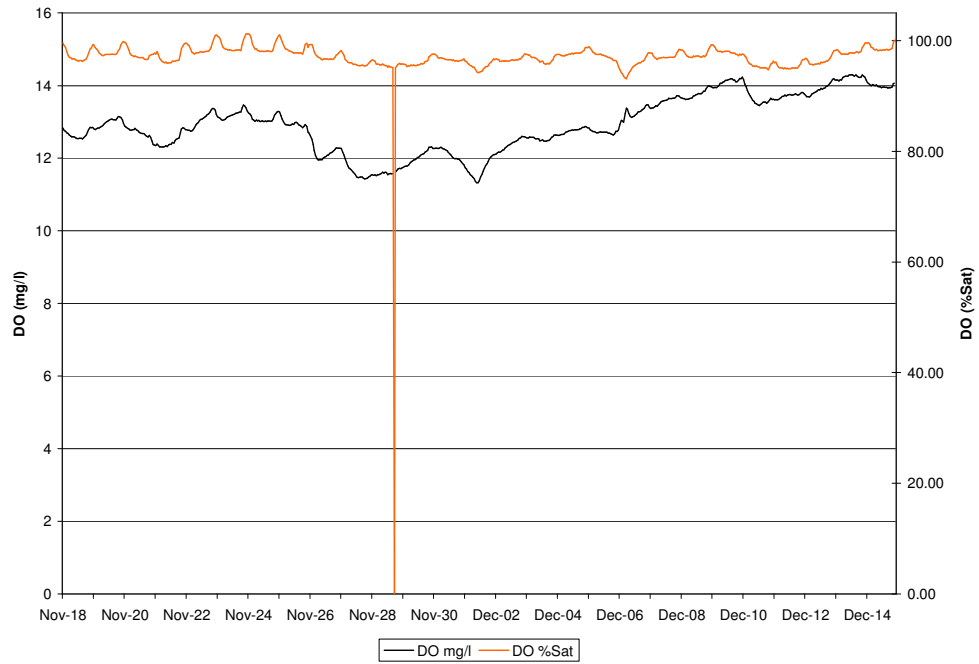
**Figure 9: Dissolved Oxygen at Rattling Brook below Bridge**

- Dissolved oxygen in Rattling Brook ranged from 11.32 to 14.30 mg/l during the deployment; reaching a minimum on December 1<sup>st</sup> and a maximum on December 14<sup>th</sup>. Dissolved oxygen remained above the CCME guideline of 9.5 mg/l for this period of time and continued to rise as water temperature declined into December.

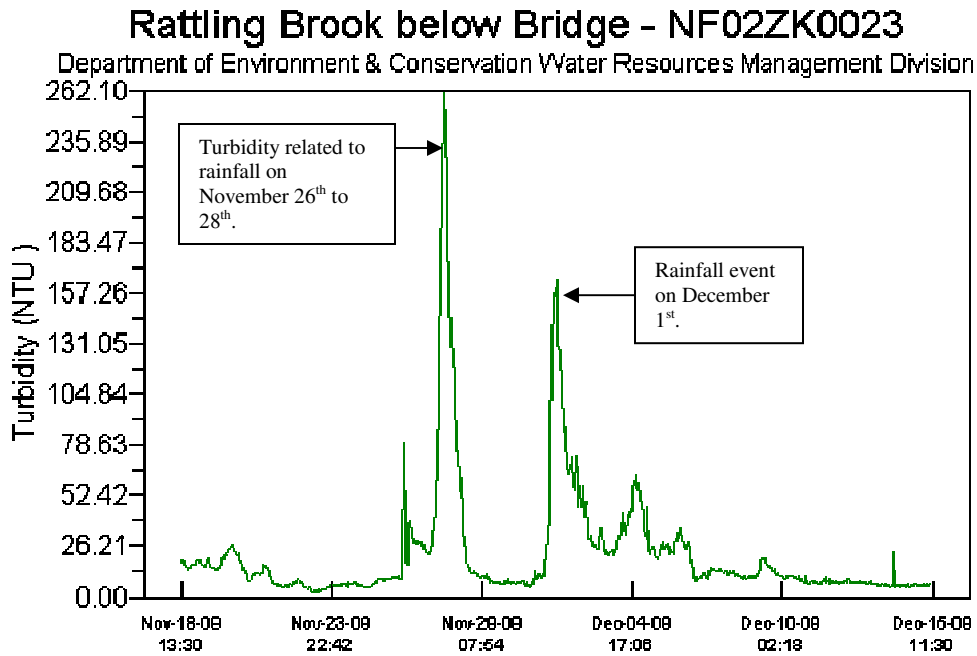
Figure 10: Turbidity at Rattling Brook below Bridge

- From October 2009 to November 2009, high precipitation amounts, coupled with insufficient runoff storage and settling capacity, allowed silt-laden water to pass into the Rattling Brook system. This is evident in the turbidity graphs at Rattling Brook below Bridge and below Pond Discharge stations. Work has been undertaken to increase the ability to settle silt-laden water before discharge into Rattling Brook.

- Turbidity averaged 22.0 NTU during the deployment period with a low of 2.4 NTU on November 23<sup>rd</sup> and a high of 262.1 NTU on November 27<sup>th</sup>.

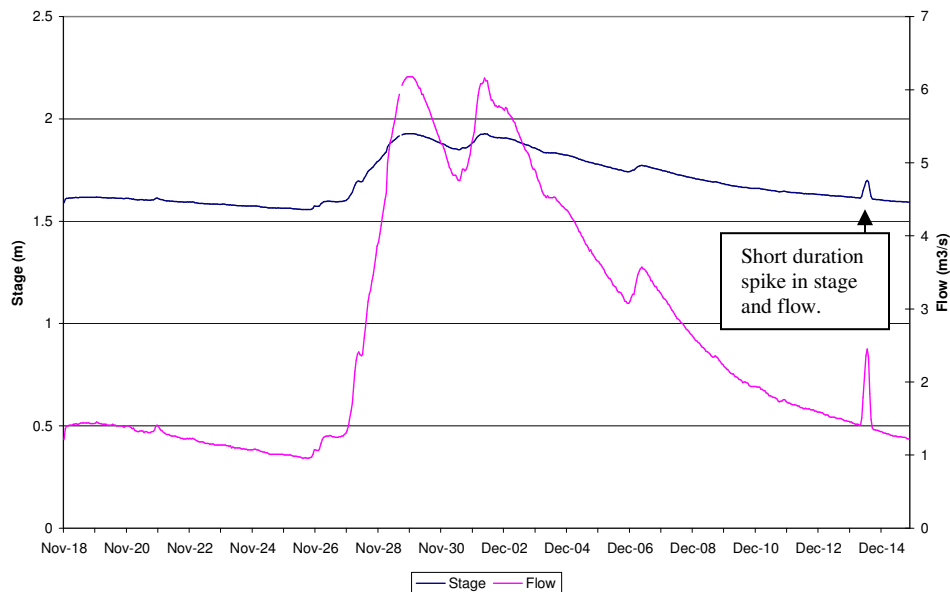
Figure 11: Stage and Flow at Rattling Brook below Bridge

- Flow at Rattling Brook below Bridge ranged from a low of 0.96 m<sup>3</sup>/s to 6.18 m<sup>3</sup>/s following precipitation. A short surge in stage and flow is identified on December 13<sup>th</sup>. An associated precipitation or temperature relationship cannot be identified. A declining trend is seen going into late December.

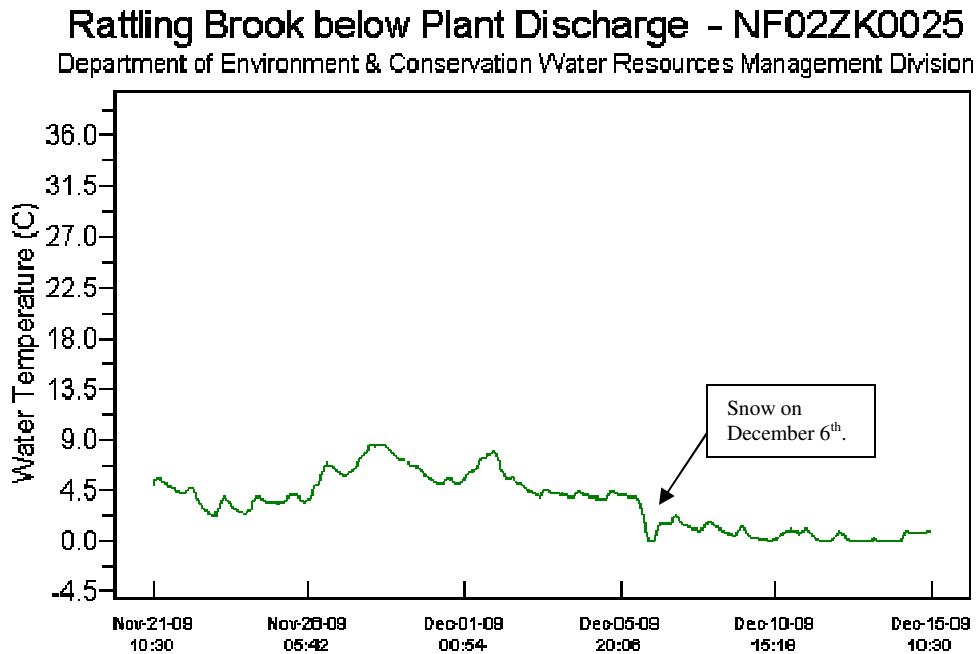
Figure 12: Water Temperature at Rattling Brook below Plant Discharge

- Temperature at Rattling Brook below Plant Discharge ranged from 0.02°C to 8.58°C during the deployment period. A snowfall on December 6<sup>th</sup> caused a short term drop in water temperature.

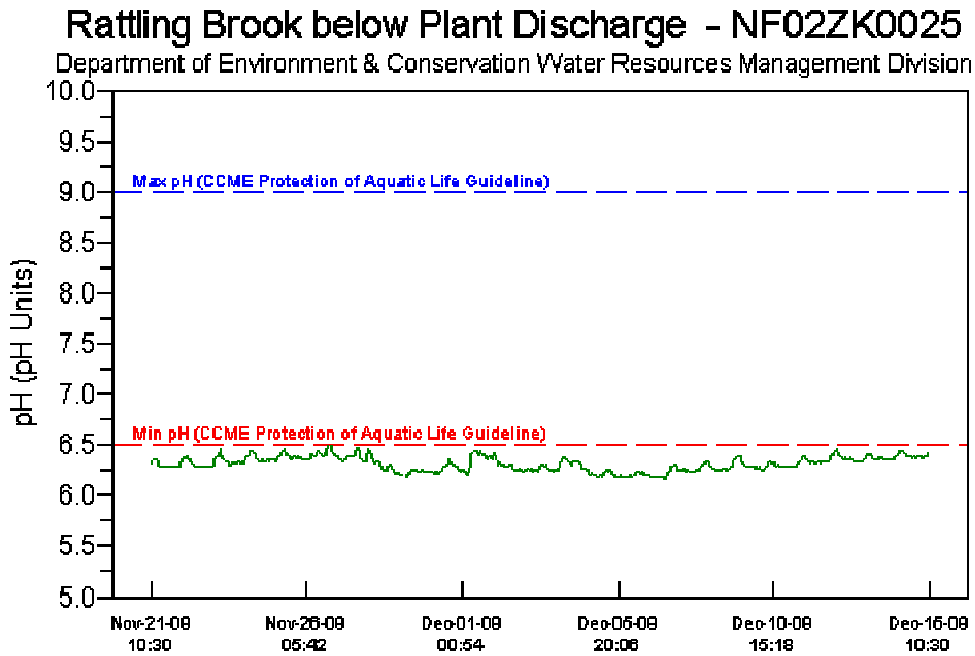
Figure 13: pH at Rattling Brook below Bridge

- pH at Rattling Brook below Bridge was below the CCME Guideline of 6.5 for almost the entire month. pH ranged from 6.17 to 6.51. No concern is warranted with regards to pH as this is likely the natural condition of pH in this river system.

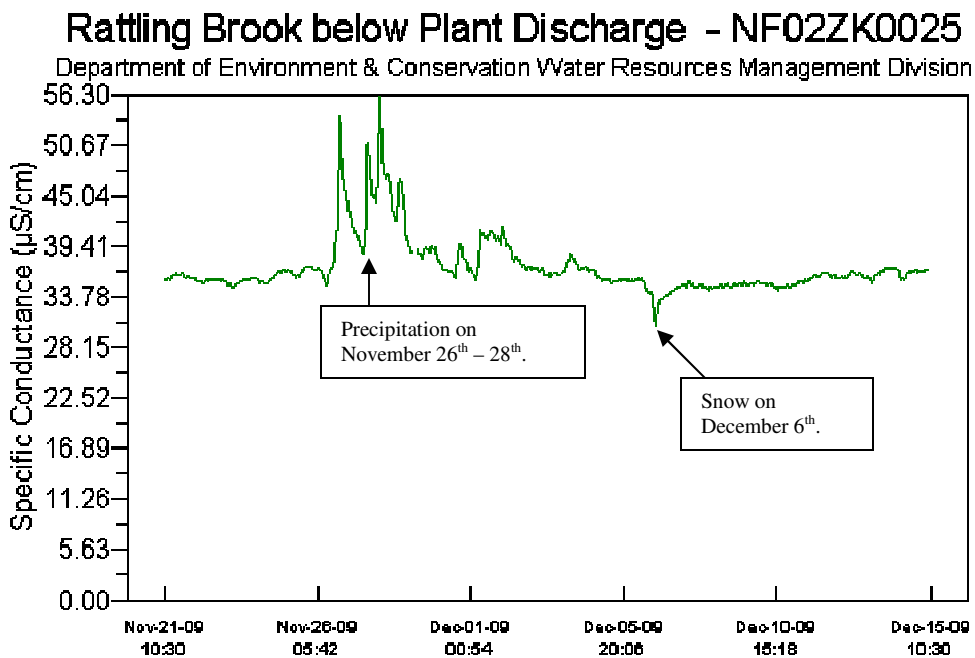
Figure 14: Specific Conductance at Rattling Brook below Plant Discharge

- Specific Conductivity ranged from 30.6 to 56.3  $\mu\text{S}/\text{cm}$  from November 21<sup>st</sup> to December 15<sup>th</sup>. A set of spikes in conductivity occurred from November 26<sup>th</sup> to the end of November 28<sup>th</sup> due to heavy precipitation. A dip in conductivity on December 6<sup>th</sup> resulted from snow on that day.

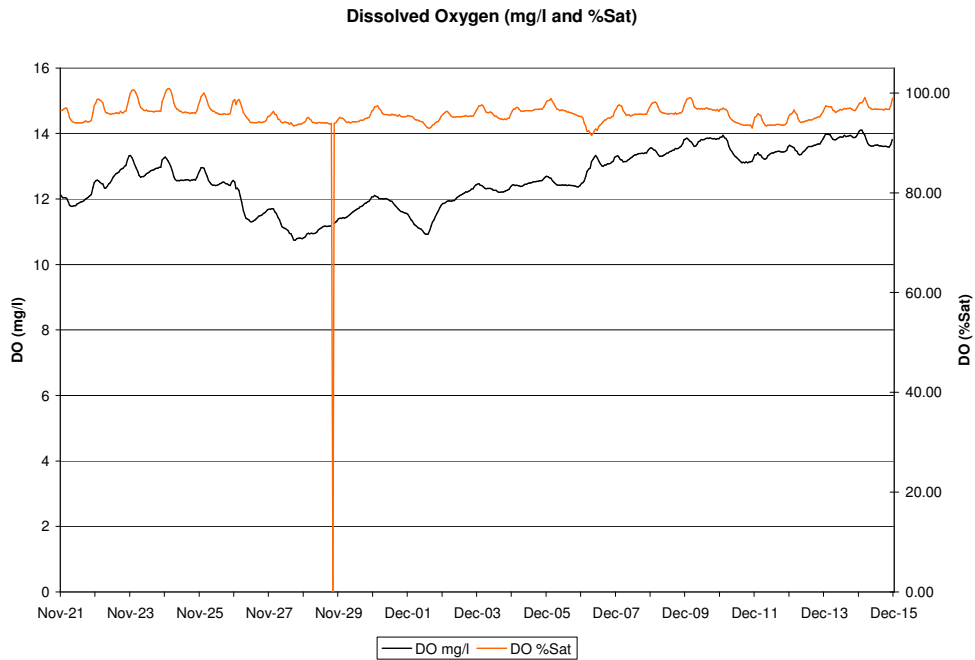
**Figure 15: Dissolved Oxygen at Rattling Brook below Plant Discharge**

- Dissolved oxygen at Rattling Brook below Plant Discharge remained above the CCME guideline of 9.5 mg/l for the whole deployment since the range was from 10.74 to 14.1 mg/l. A rising trend occurred in the later half of the deployment as water temperature decreased.

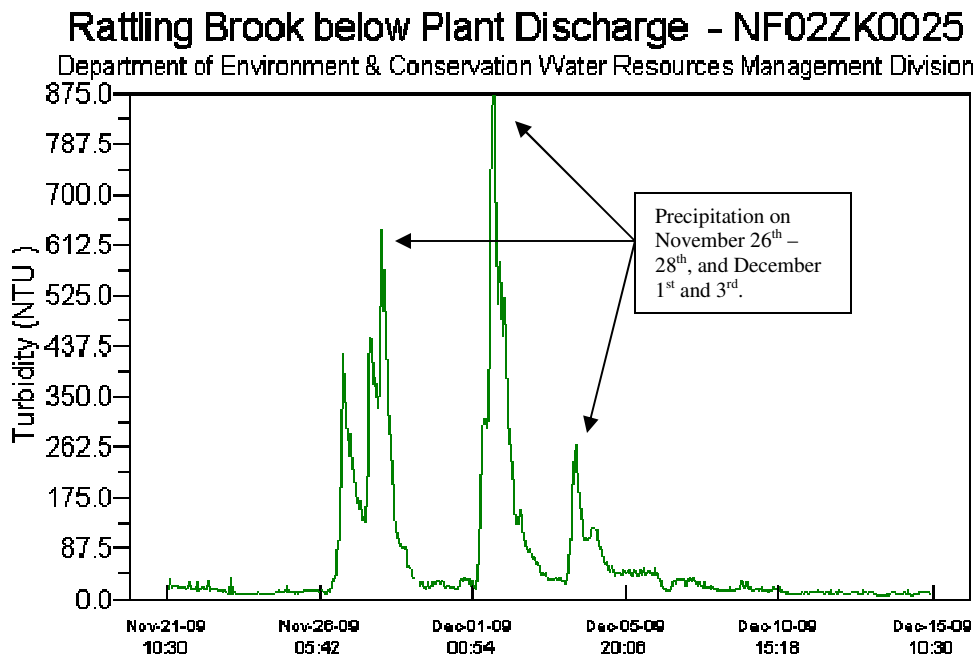
**Figure 16: Turbidity at Rattling Brook below Plant Discharge**

- From November 2009 to December 2009 waterlogged unsuitable material such as peat and overburden removed from the construction site was found to be spilling from trucks hauling the material to Unsuitable Materials Site (USM) #1. Once deposited in USM #1, the material continued to drain silt-laden water into the Rattling Brook system due to insufficient drainage structures.

- Three major sets of peaks (875, 649, and 267.8 NTU) were observed in turbidity at Rattling Brook below Bridge. The lowest value recorded over the deployment period was 8 NTU.

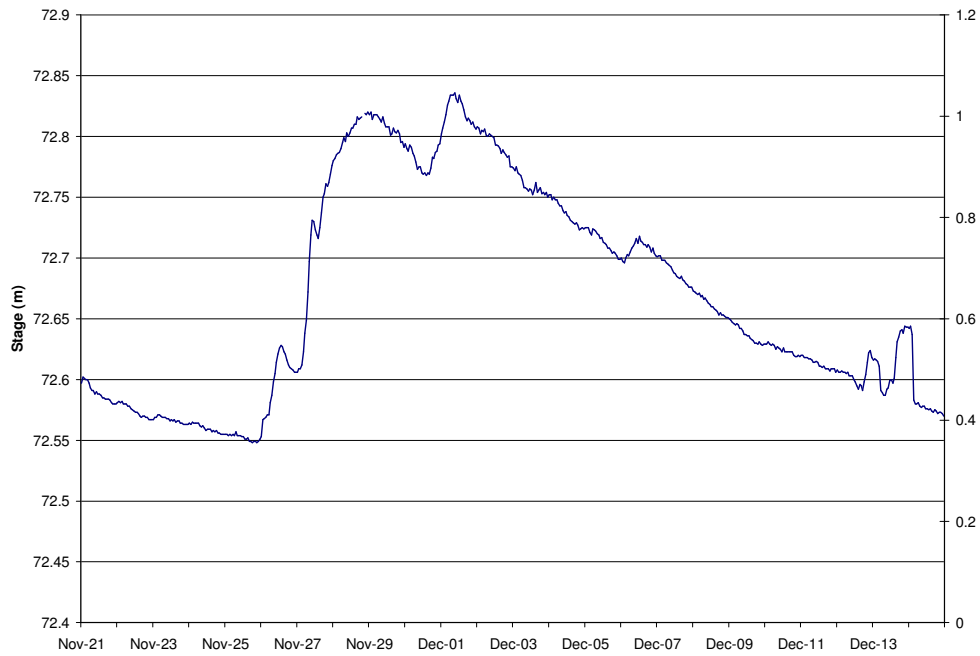
**Figure 17: Stage at Rattling Brook below Plant Discharge**

- Stage at Rattling Brook below Plant Discharge ranged from 72.5 to 72.8 m over the deployment period. Since a flow curve has not been developed for this section of the river, flow rate cannot be estimated.
