Real Time Water Quality Monthly Report: Lower Humber River @ Humber Village Bridge August 2004

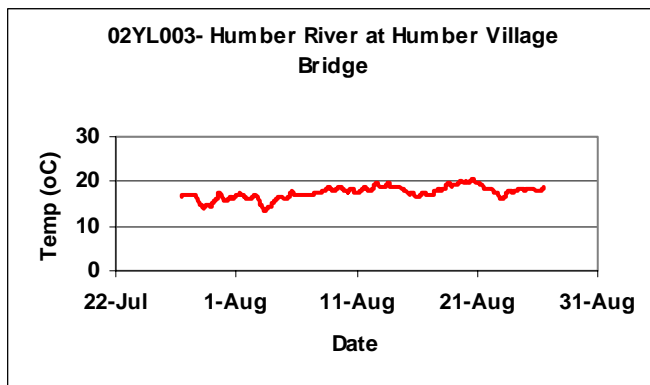
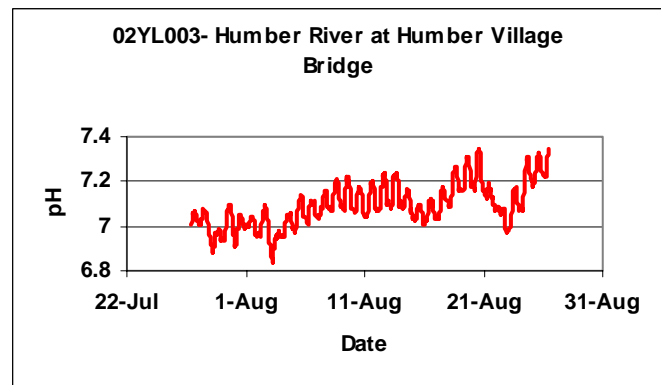
- During the period from July 27th, 2004 to Aug 26th, 2004 parameters displayed normal behaviour except for turbidity which lost its calibration.
- Water temperature continued to increase as ambient air temperature increased. Diurnal fluctuations in water temperature due to daytime warming and nighttime cooling effects were less pronounced during this period. pH displayed normal fluctuations in range with typical pH values for the Humber River. pH also showed greater diurnal variation and a tendency to drift upward.

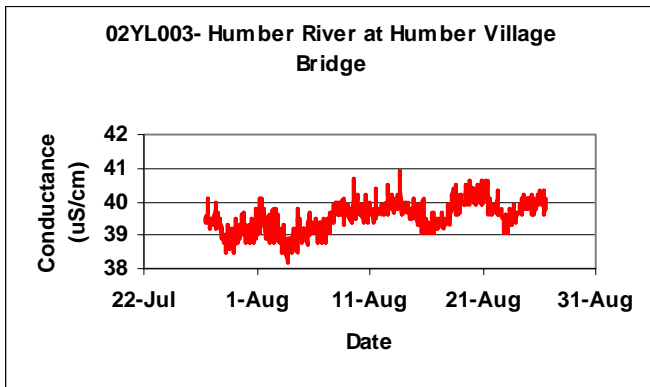
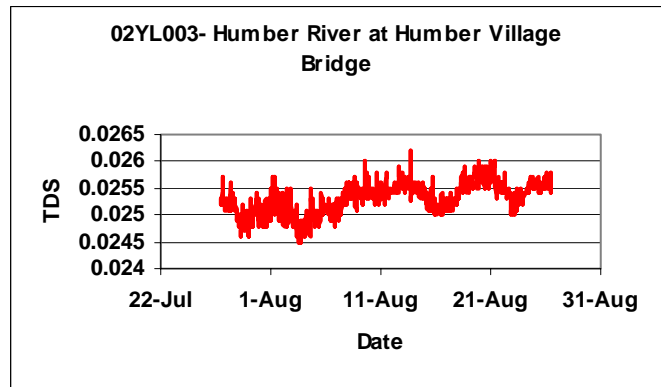
- Conductance values for this period fell within normal range for the Humber River. Both conductance and dissolved solids displayed slight increasing trends over this period. Dissolved solids tend to become more concentrated with decreased runoff. The dips in conductivity and TDS coincide with the dips observed in pH and the increase of runoff noted on the Stage graph during the latter period of August.

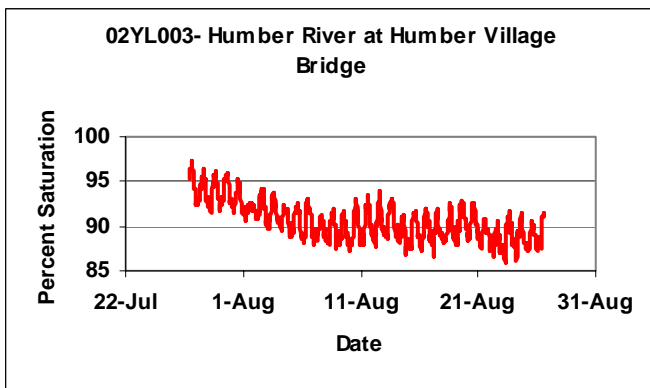
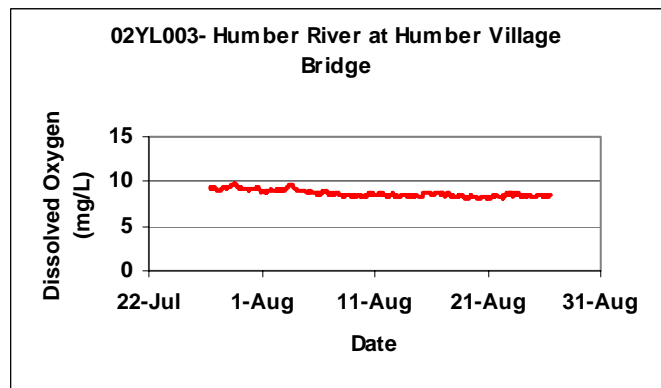
- Oxygen levels decreased over the first part of this period corresponding to the increase in water temperature.

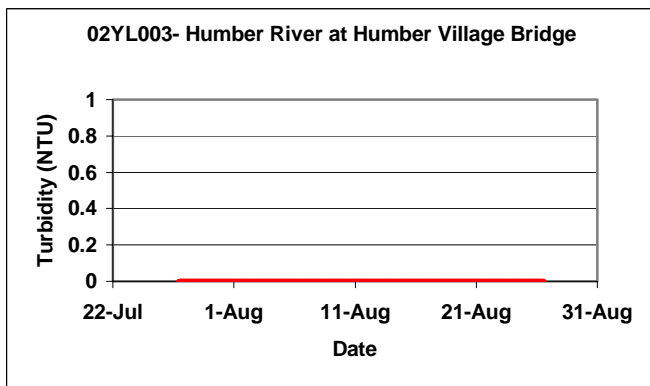
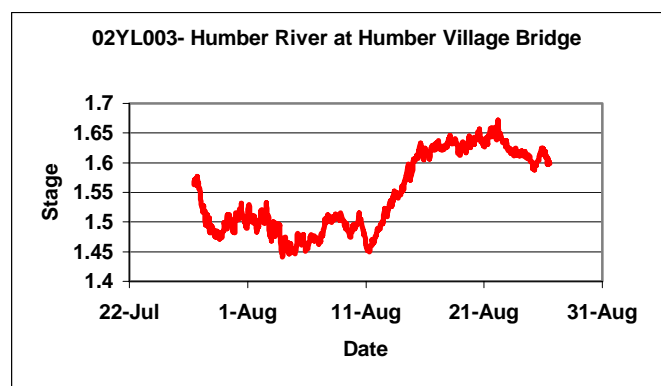
- All sensors seemed to calibrate without problems, however, once the Datasonde was removed for this period it was found that the turbidity probe had somehow lost its calibration.
- Comparative water quality readings were taken with a Minisonde during the reinstallation of the Datasonde to ensure readings were correct. This procedure is also required as part of the QA/QC protocol. The Minisonde was calibrated before use.
- A water sample was taken for laboratory analysis as part of QA/QC procedures on reinstallation.

- Background turbidity levels read 0 NTU throughout this entire period due to a calibration error with the turbidity sensor. Streamflow was low, only seeing an increase by mid-August with rainier weather.
