Real Time Water Quality Monthly Report for Voisey's Bay Nickel Company Ltd. September 2003

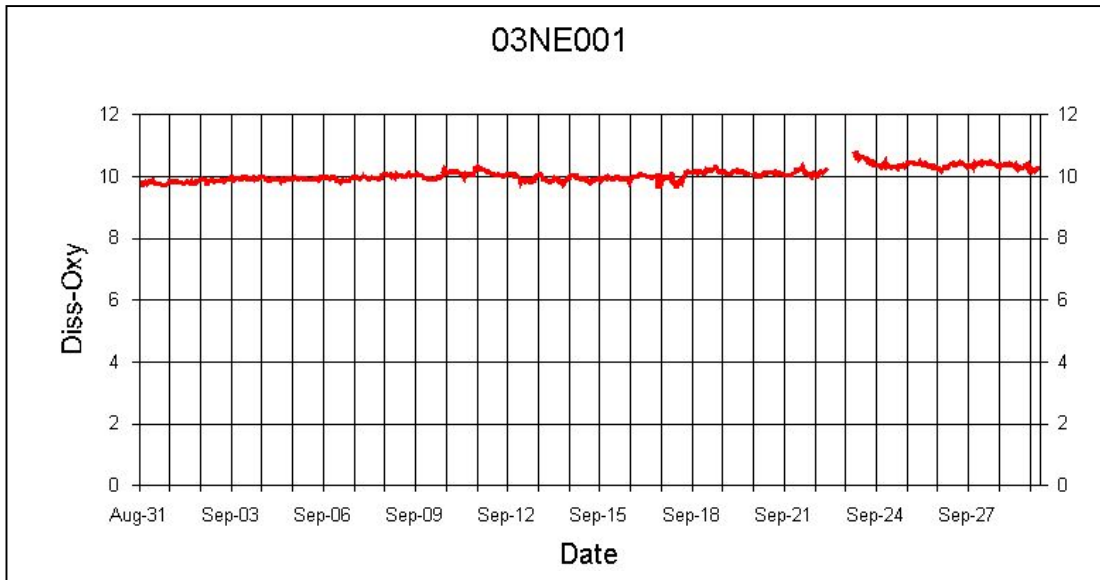
Figure 1

- Throughout the month of September most water quality parameters remained at expected background levels. An example of this steady-state can be seen in the dissolved oxygen levels at the Outlet of Reid Pond into Reid Brook (**Figure 1**).

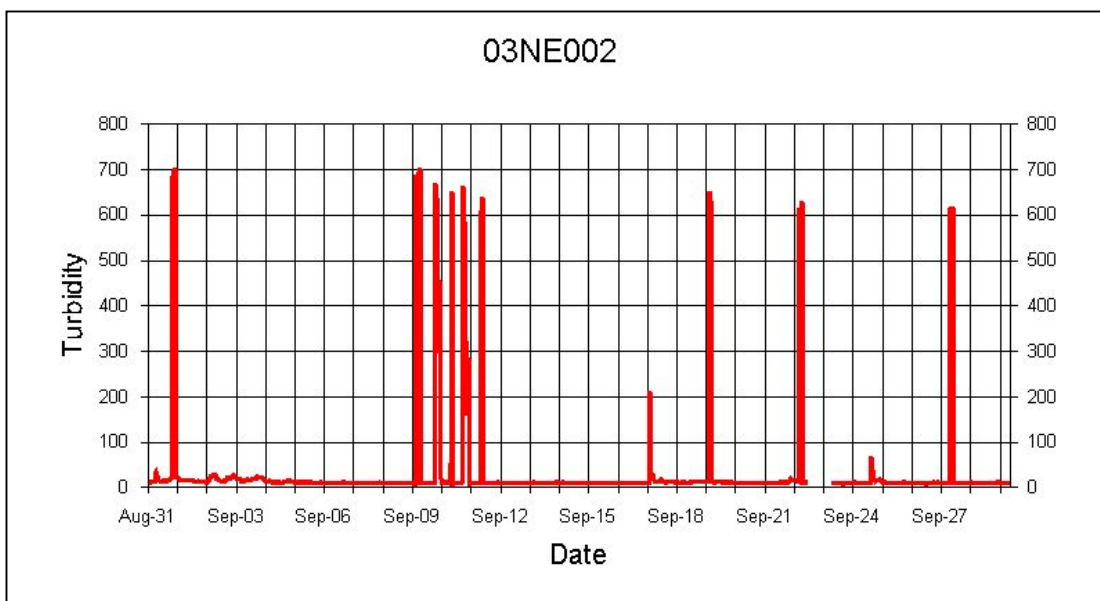
Figure 2

- There were a number of significant spikes in the turbidity levels in Camp Pond Brook below Camp Pond throughout the month of September (**Figure 2**). Each of these spikes was reported to the Environmental Officer (on-site) by email or telephone. This issue of high turbidity in this area has been investigated by numerous parties (on-site) throughout the past few weeks and is presently being mitigated. It appears as though the real-time station located on Camp Pond Brook will be the station most likely to pick up any rise in turbidity levels due to the close proximity of construction of the mill site.

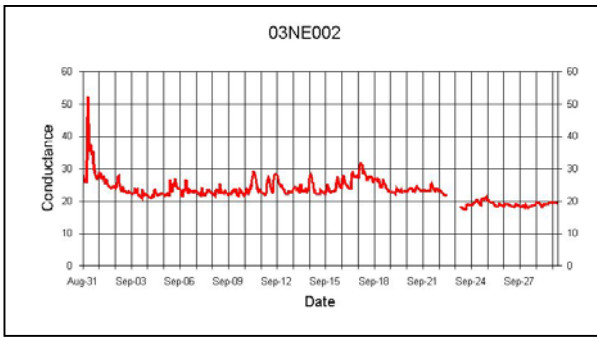
Figure 3

- As a result of the increased turbidity at Camp Pond Brook, other parameters such as conductivity and total dissolved solids also showed slight increases (**Figures 3 and 4**).

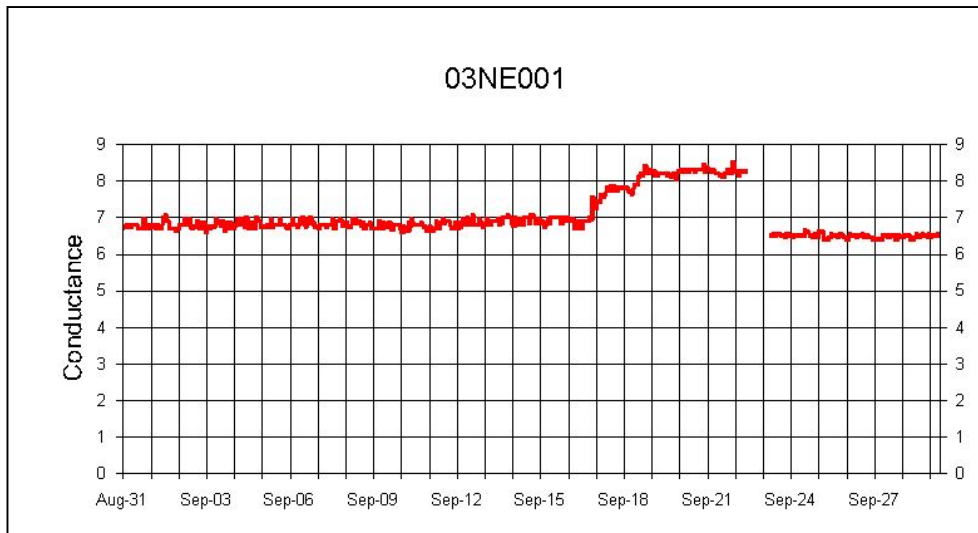
Figure 5

- It is important to note that turbidity levels at the Lower Reid Brook site did not rise in accordance to those at Camp Pond Brook. This is an indication that the sediment is settling out before it reaches the station on Lower Reid Brook.
- There was an interesting increase in conductivity values for the station at the Outlet of Reid Pond the week before the calibration was scheduled to take place (**Figure 5**). It is difficult to give an explanation for this increase, however, it is possible that the instrument began to lose its calibration. It remained steady after it was maintained and calibrated.
