## Real Time Water Quality Monthly Report for Voisey's Bay Nickel Company Ltd. September 2005

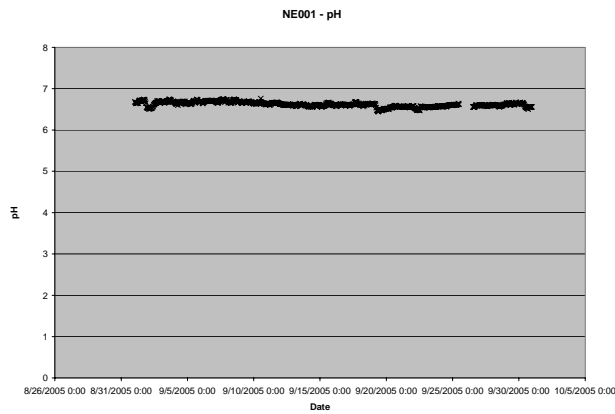
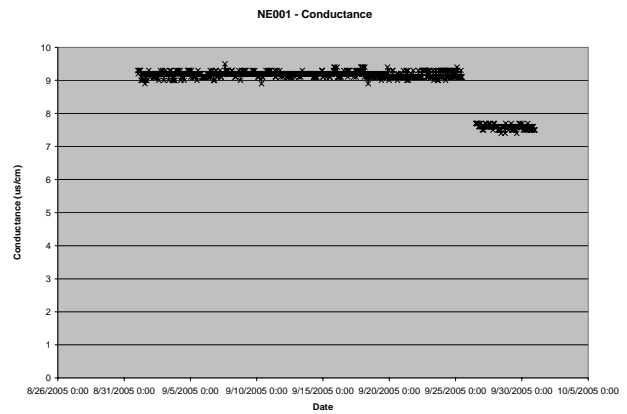
- Throughout the month of September, most water quality parameters at the Upper Reid Brook station remained steady at expected background levels. As can be seen by the graphs, pH and conductivity (Figures 1 & 2) remained very consistent throughout the month. There is a decrease in conductance after calibration of the instruments of approximately 1.5  $\mu\text{s}/\text{cm}$ .

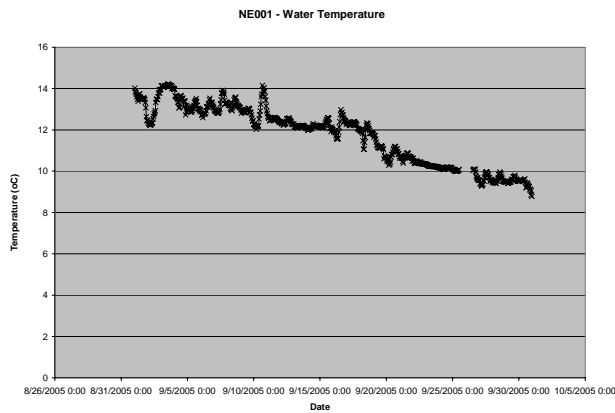
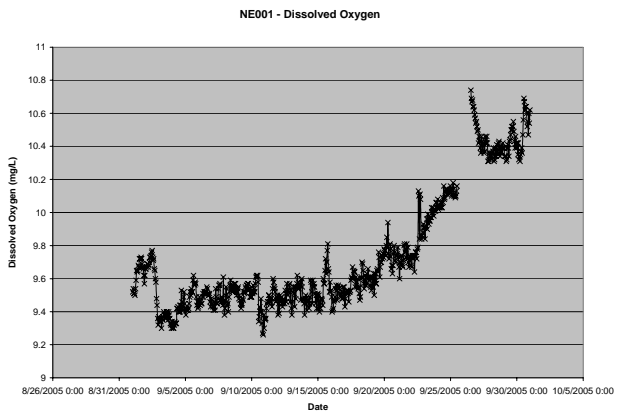
- Temperature (Figure 3), as expected for this time of year, has started to decrease during the month of September. The dissolved oxygen (Figure 4) began to increase during the month of September. This corresponds with the natural ability of water to have higher concentrations of dissolved oxygen when lower water temperatures are present.

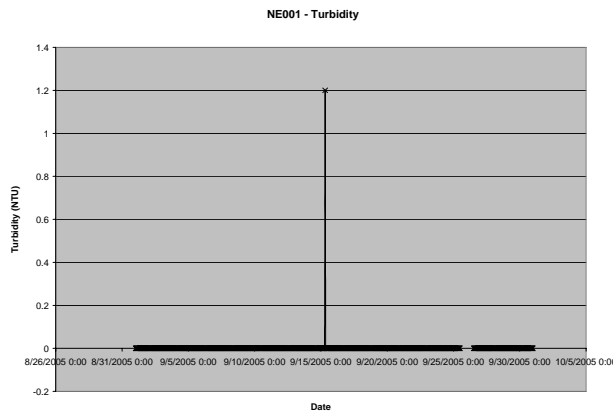
Figure 5

- The turbidity (Figure 5) is stable at 0 NTU with one small spike of 1.2. NTU in turbidity on September 15<sup>th</sup>, 2005.

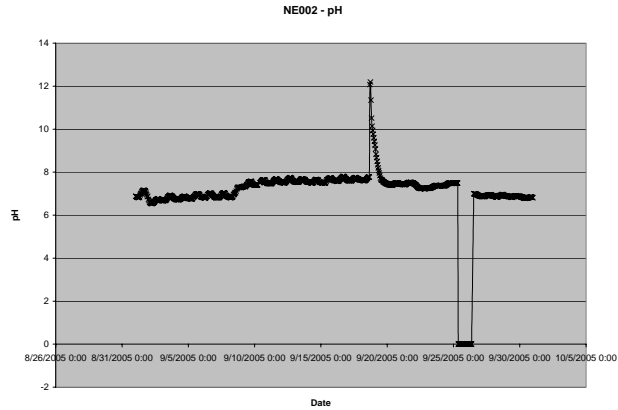
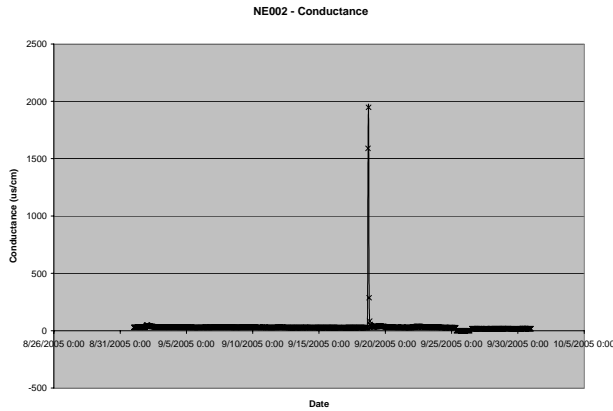
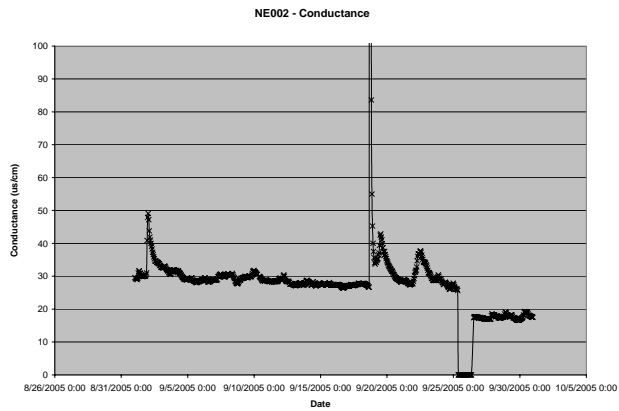
- Throughout the month of September, the pH and conductance (Figure 6 & 7 respectively) in Camp Pond Brook remained relatively consistent with the exception of a significant spike on September

18<sup>th</sup>. This spike is consistent with a spill that occurred from a tailings pipe that was reported on September 19<sup>th</sup>. Water with pH 12 was released from the tailings piping and caused both pH and conductance to increase in Camp Pond Brook for a short period of time. Figure 8 shows the conductance with the scale changed to show the spikes in conductance throughout the month of September. There were spikes in conductance on September 2<sup>nd</sup>, September 19<sup>th</sup> and September 22<sup>nd</sup>. These spikes are likely to be due to the tailing pipe releases.

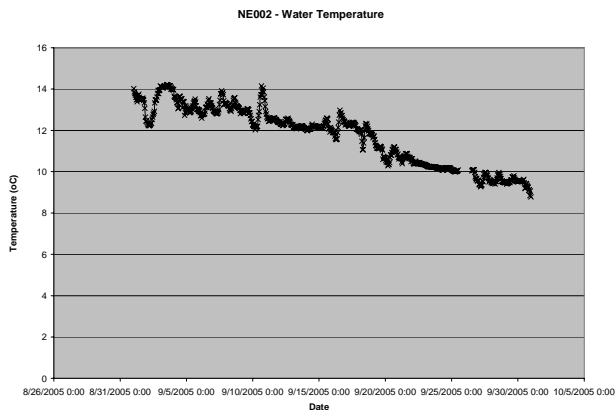
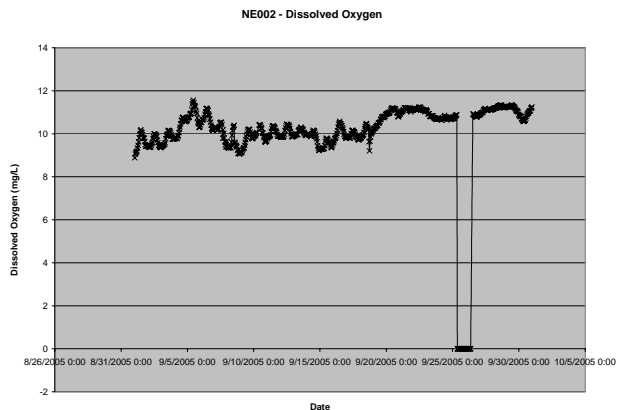
- Temperature (Figure 9) decreased during the month of September which is consistent with this time of the year. The dissolved oxygen (Figure 10) showed a slight increase during September. This corresponds with the natural ability of water to have higher concentrations of dissolved oxygen when lower water temperatures are present.

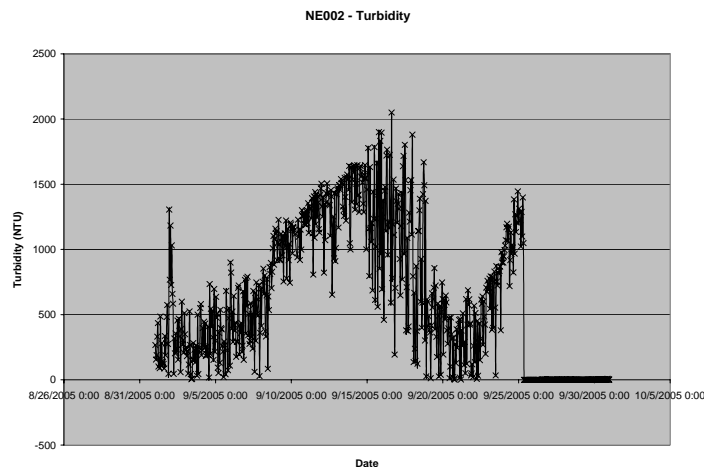
*Figure 11*

- Throughout the month of September there was significant activity experienced with the Hydrolab at the Camp Pond Brook station for turbidity (Figure 11). There was a severe increase in turbidity from September 1<sup>st</sup> to September 16<sup>th</sup>. This increase began on August 24<sup>th</sup>.

- DOEC informed VBNC Environmental Staff of the turbidity increase seen in Camp Pond Brook (since August 24<sup>th</sup>) on September 1<sup>st</sup>. Environmental Staff informed DOEC that the most recent (September 1-2<sup>nd</sup>) turbidity spikes could have been due to extreme precipitation during that time. The Environmental Officer walked down to Camp Pond Brook and saw no visible colour changes in the brook. He suspected however, that it could have been elevated organics and larger sediments that contributed to the spike.

- DOEC staff informed VBNC Environmental Staff on September 6<sup>th</sup> that turbidity values in Camp Pond Brook continued to increase. Despite further investigation by VBNC Environmental Staff there was no explanation at this time for the increase in turbidity.

- Between September 7-9<sup>th</sup>, DOEC spoke with VBNC Environmental Staff regarding the increasing turbidity. It was noted that the two regular Environmental Staff that have been trained to work with the Hydrolabs were not on-site until September 20<sup>th</sup>. DOEC informed VBNC that the turbidity values in Camp Pond Brook have continued to increase. VBNC staff walked down to Camp Pond Brook on September 8<sup>th</sup> to investigate. The Hydrolab was taken out of the water and it was noted that there was algae growth on the sensors. The sensors were cleaned of algae in the field and the Hydrolab was returned to the water. The removal of the algae did not appear to affect the turbidity readings as the website showed no signs of decreasing turbidity. The turbidity probe has a self-cleaning process that cleans the probe prior to taking a measurement.

- After September 16<sup>th</sup> the turbidity was still fluctuating but showed a decrease until approximately September 22<sup>nd</sup>.
- DOEC spoke with VBNC Environmental Staff to inform them that they would be travelling to Voisey's Bay on September 23<sup>rd</sup> for the maintenance and calibration of all three Hydrolabs.

- Between September 18<sup>th</sup> to September 22<sup>nd</sup>, the fluctuations in turbidity ranged from 1 NTU to 1669 NTU. This seems to be due to the tailings pipe leak discussed earlier with respect to pH and conductance. The increases that were seen earlier in August and September may be associated with leakages from the tailings pipe that eventually spilled on September 18<sup>th</sup>.

- An increase in turbidity began again on September 22<sup>nd</sup> until the Hydrolab was taken out for calibration on September 25<sup>th</sup>.
- After calibration of the instrument on September 26<sup>th</sup>, the turbidity values decreased to background levels.

- Conversations between DOEC and VBNC Environmental Staff determined that it would be beneficial to remove the Hydrolab at Camp Pond Brook when trained staff returned on the 20<sup>th</sup>.

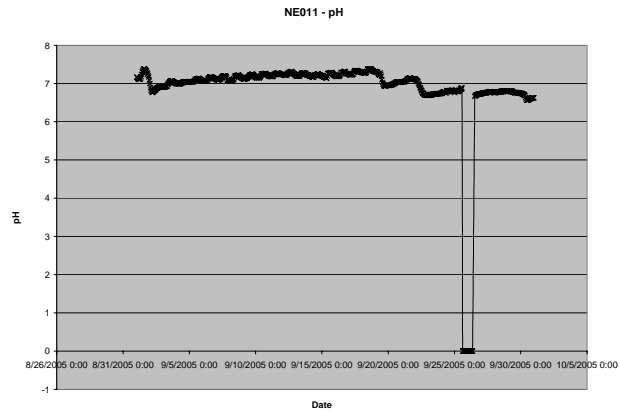
*Figure 12*

- Throughout the month of September, the pH (Figure 12) in Lower Reid Brook remained relatively stable with a slight increase throughout the first part of September and a slight decrease towards the end of the month. There is a decrease in pH after calibration of the instrument

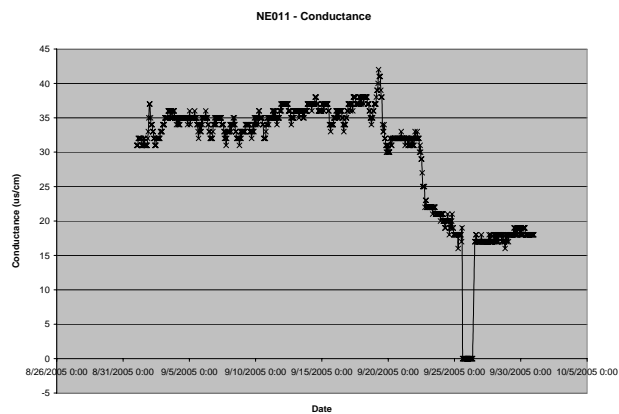
*Figure 13*

- The conductance during the first half of September (Figure 13) remained relatively stable until September 19<sup>th</sup> when there was a spike and then the conductance decreased quite rapidly. This spike in conductance is likely due to the tailing pipe spill discussed earlier with respect to pH and conductance in Camp Pond Brook. It occurs approximately 11 hours after the spike in conductance at the Camp Pond Brook station.

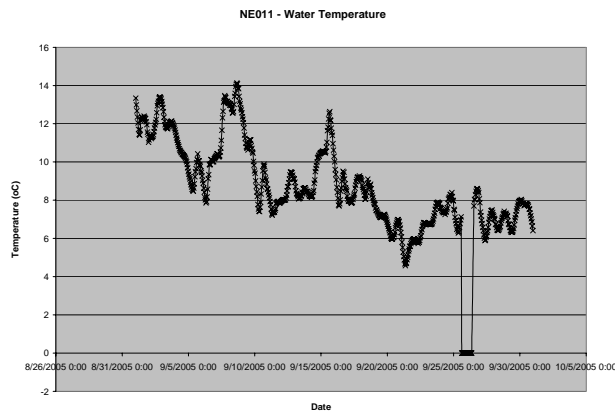
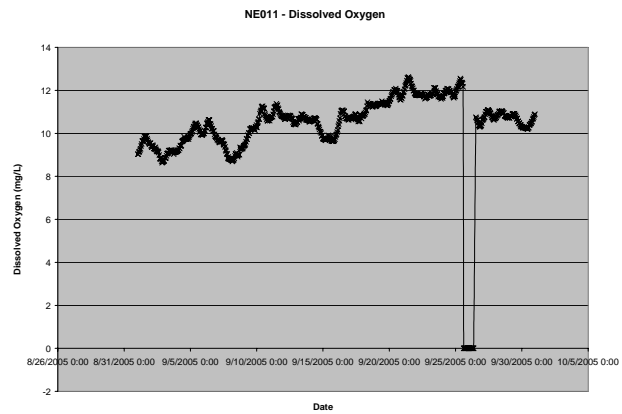
- Temperature (Figure 14) showed fluctuations throughout the month of September. There is, however, a distinctive trend of decreasing temperatures throughout the month. The dissolved oxygen (Figure 15) shows fluctuations as well with an increasing trend. This corresponds with the natural ability of water to have higher concentrations of dissolved oxygen when lower water temperatures are present.

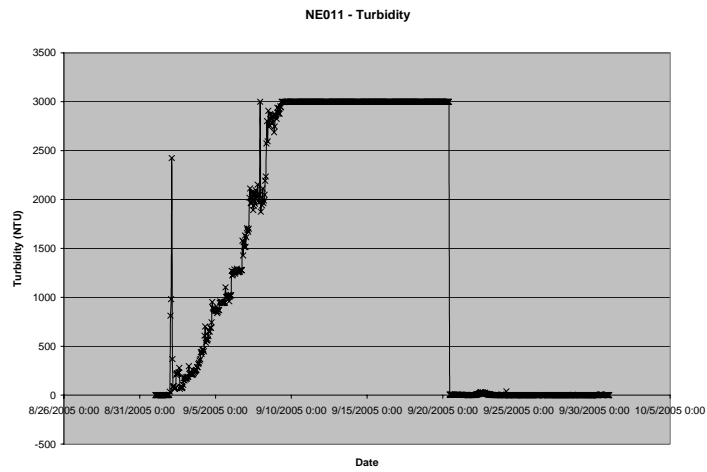
*Figure 16*

- Turbidity values (Figure 16) for the beginning of September were at background levels. On September 2<sup>nd</sup>, a drastic and steady increase of turbidity values was experienced. The increase continued until September 9<sup>th</sup> when the Hydrolab reached its maximum turbidity value of 3000 NTU.

- When DOEC staff informed VBNC Environmental Staff on September 6<sup>th</sup> that turbidity values in Camp Pond Brook continue to increase. It was also noted that Lower Reid Brook show increasing turbidity values since September 2<sup>nd</sup>. Despite further investigation by VBNC Environmental Staff there was no explanation at this time for the increase in turbidity.

- The increase in turbidity values began on September 1<sup>st</sup> approximately seven (7) days after the turbidity in Camp Pond Brook began to increase.

- Between September 7-9<sup>th</sup>, DOEC spoke with VBNC Environmental Staff regarding the increasing turbidity. DOEC informed VBNC that the turbidity values in Lower Reid Brook have continued to increase reaching the maximum value for the Hydrolabs of 3000 NTU.

- On September 20<sup>th</sup>, the turbidity values suddenly decreased (within an hour) from the maximum 3000 NTU to background levels of 0-6 NTU.
- On September 22<sup>nd</sup>, turbidity levels again spiked slightly above background levels for approximately 12 hours with a maximum value of 30 NTU. On September 23<sup>rd</sup>, the turbidity values returned to normal background levels.

- It was noted by VBNC staff that the turbidity spikes may be due to the calibration of the Hydrolab instrumentation. This is not the case with Lower Reid due to the fact that the turbidity readings returned to background levels (September 23<sup>rd</sup>) before the calibration took place (September 26<sup>th</sup>).

- The increases that were seen earlier in September are likely due to the leaking of the tailings pipe.
- After calibration of the instrument on September 26<sup>th</sup>, the turbidity values remained at background levels.
