Real Time Water Quality Monthly Report: Lower Humber River @ Humber Village Bridge February 2004

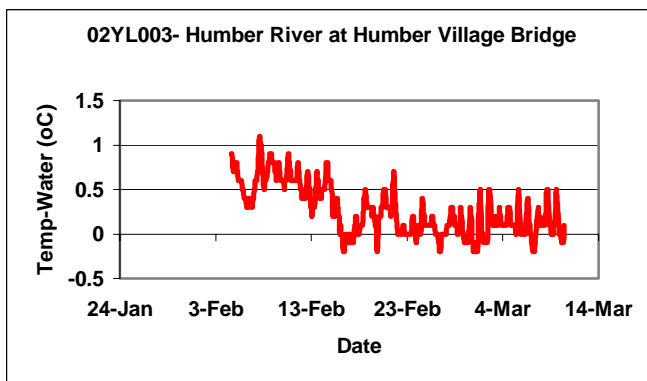
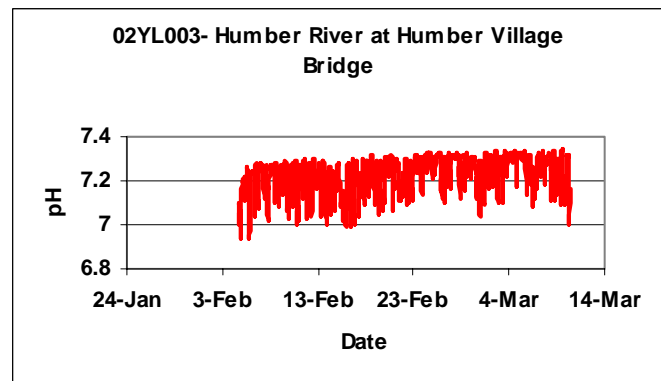
- During the period from Feb 4th, 2004 to Mar 10th, 2004 most parameters displayed normal behaviour. Water temperature continued to decrease, falling below zero by mid February by which time a sustained cold snap had set in. Ice conditions on the river and along the banks were fairly light. pH displayed normal fluctuations in range with typical pH values for the Humber River along with a slight increasing trend.

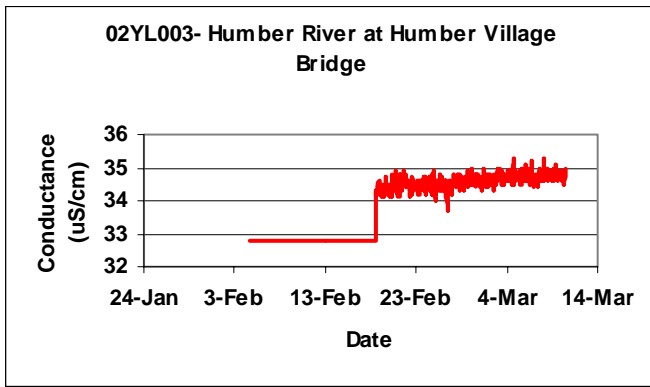
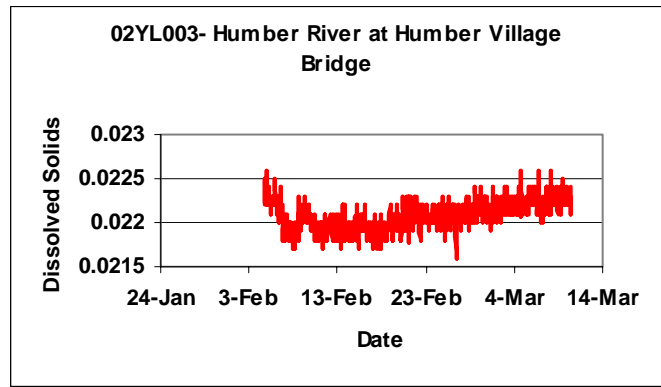
- Conductance values for this period were initially static due to a programming problem with the datalogger. Once this problem was corrected conductivity data fell within normal range for the Humber River and remained fairly constant. A dip in dissolved solids values seems to correspond to an increase in stage or streamflow during mid February.

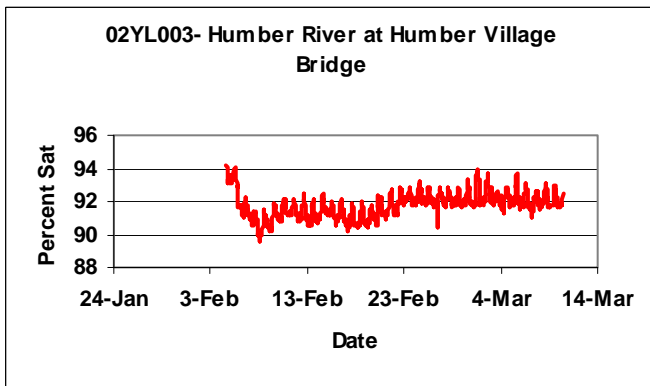
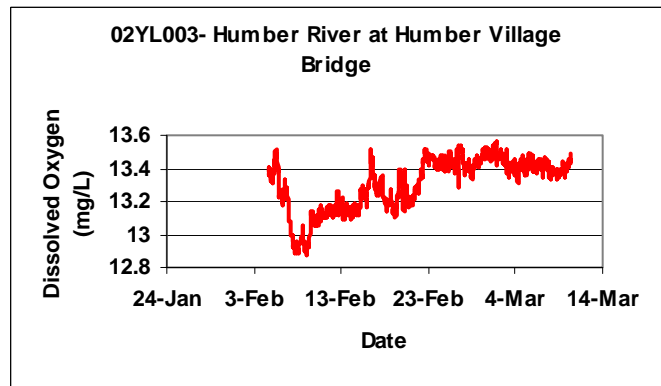
- Dissolved oxygen levels were initially high, took a dip and then worked back up. High DO corresponds with decreased water temperatures. Problems with the DO sensor now appear to be fixed.

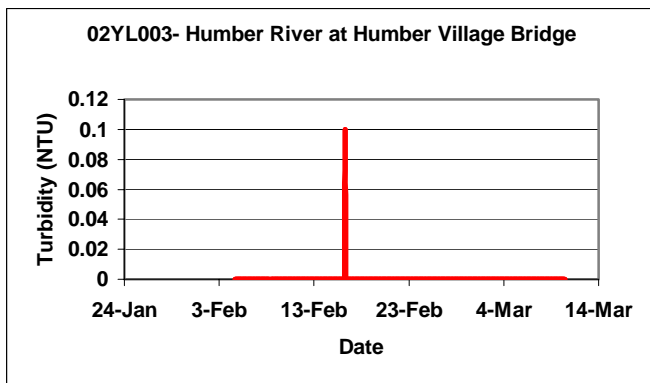
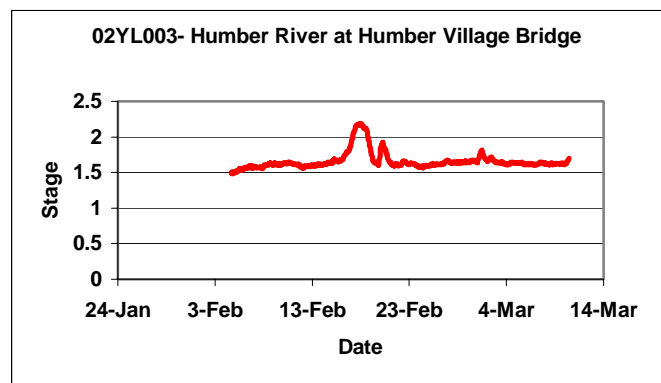
- Turbidity during this period remained at 0 NTU, except for a small spike corresponding to the observed rise in stage or streamflow. Problems with the turbidity sensor now appear to be fixed.
