Real Time Water Quality Monthly Report for Voisey's Bay Nickel Company Ltd. July - August 2007

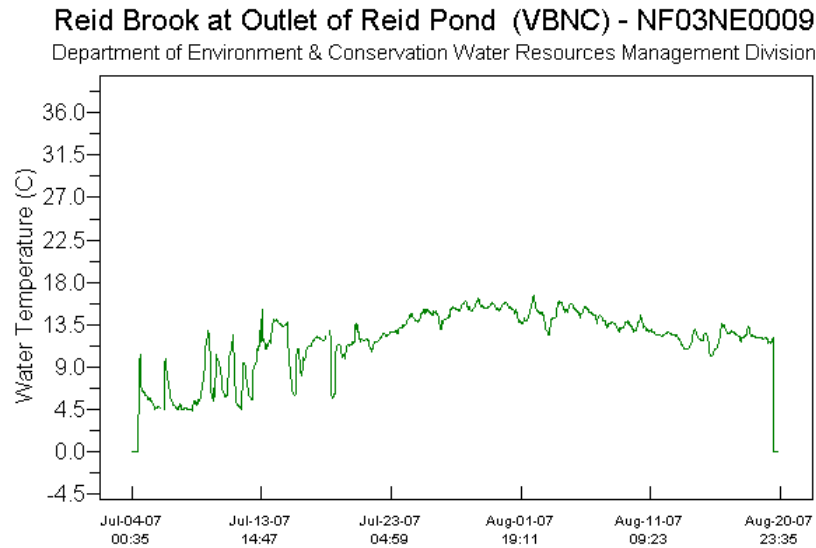
Figure 1

- The water temperature (**Figure 1**) showed an increase and then decreasing pattern throughout the deployment period. Corresponding, dissolved oxygen (**Figure 2**) showed a decrease and then increase throughout the deployment. This pattern is expected during the months of July and August.

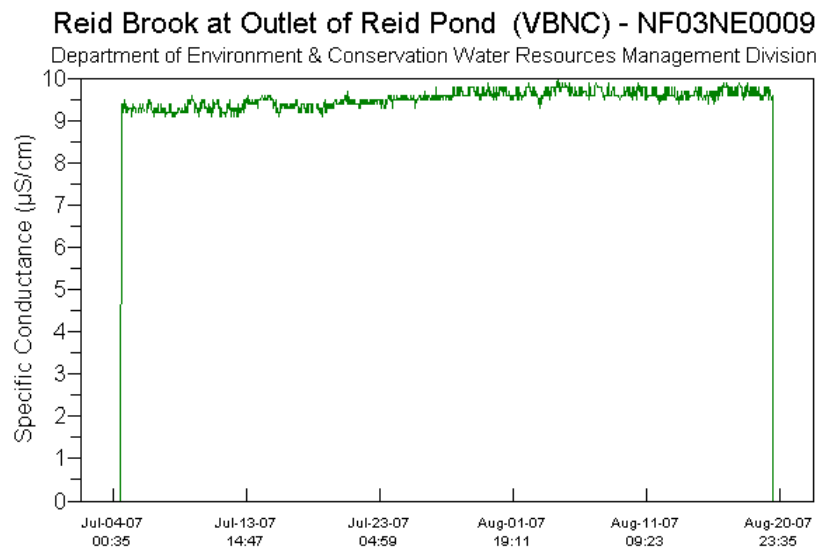
Figure 3

- The conductivity (**Figure 3**) remained very consistent throughout the deployment period.

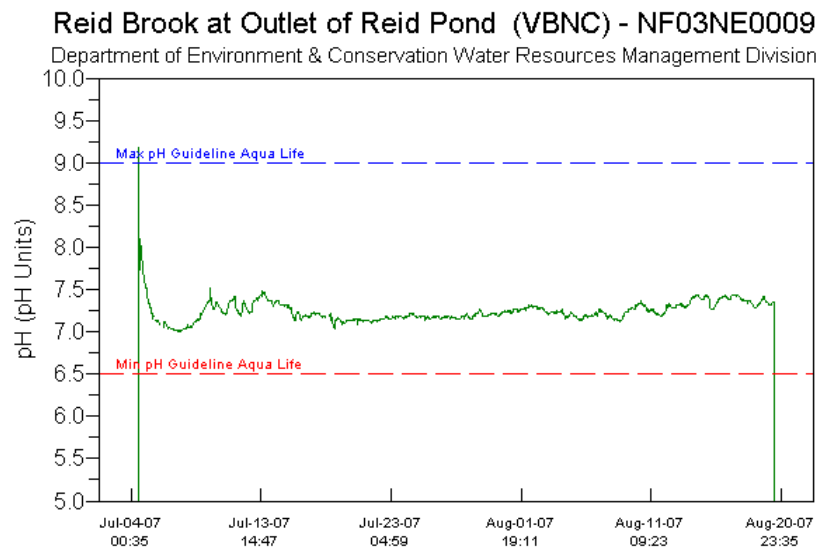
Figure 4

- The pH (**Figure 4**) values remained consistent throughout the deployment period and within CCME Water Quality Guidelines for Aquatic Life (6.5 – 9.0). The first reading after installation was likely due to an erroneous value that was recorded before the pH sensor had time to adjust to the river conditions. This type of occurrence happens occasionally when the instrument is installed close to the same time as a reading is taken by the datalogger.

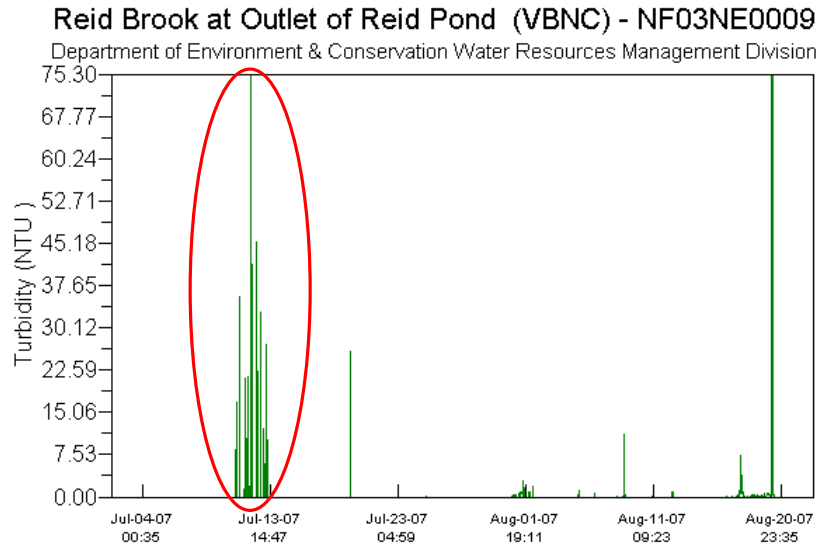
Figure 5

- Turbidity values (**Figure 5**) relatively consistently throughout the deployment period. There was one water quality incident which occurred July 12th – 13th which showed a maximum value of 75.3 NTU. This station is not affected by activities at the VBNC site and is likely due to natural conditions.

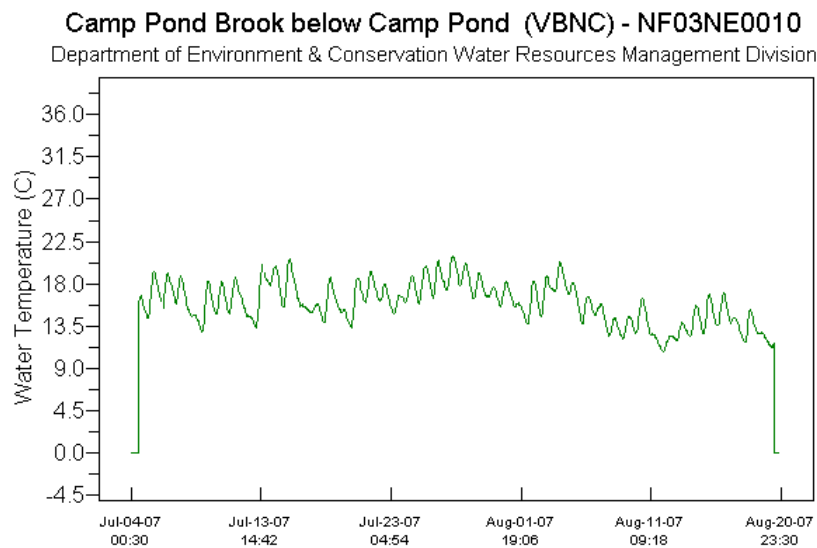
Figure 6

- Water temperature and dissolved oxygen (**Figures 6 & 7**) remained relatively stable during the deployment period of July to August.

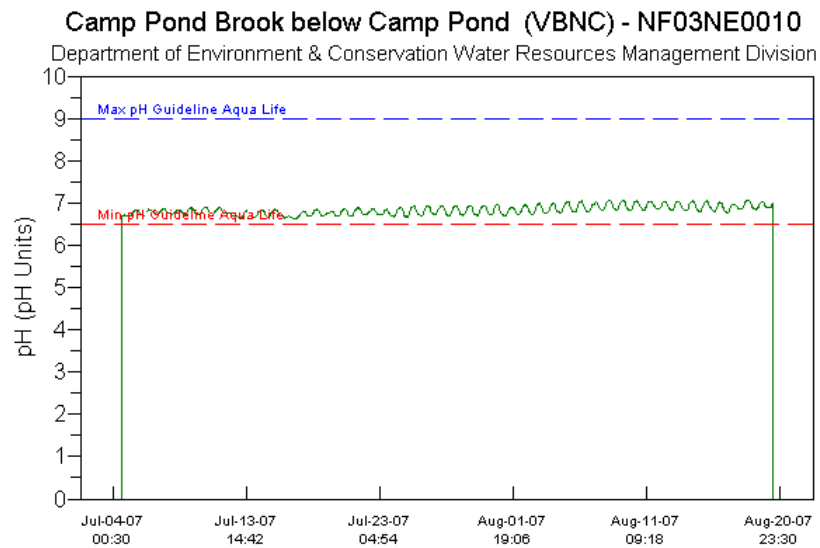
Figure 8

- pH (**Figure 8**) remained very consistent throughout the deployment period and within CCME Water Quality Guidelines for Aquatic Life (6.5 – 9.0).

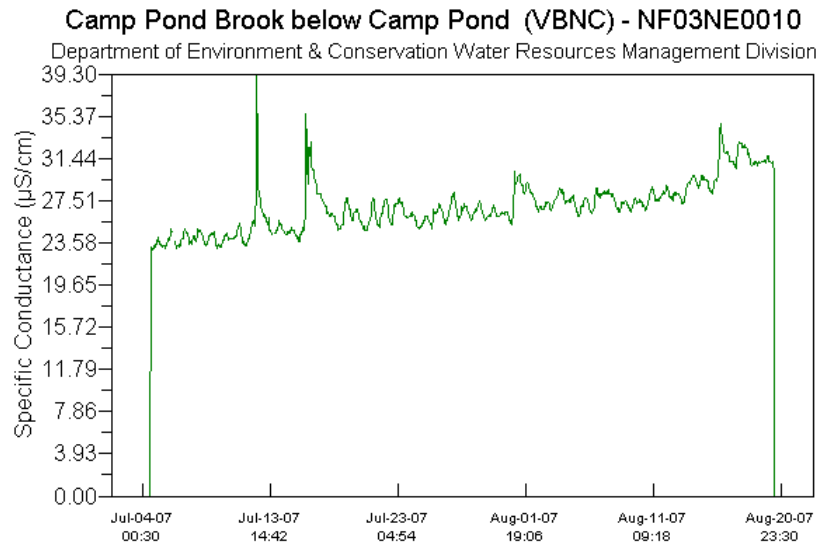
Figure 9

- The specific conductivity values (**Figure 9**) showed a slight increase throughout the deployment period with values ranging from 22.9uS/cm to 39.3uS/cm. This is consistent with a slight decrease in stage (**Figure 10**) throughout the same period of time. It is typical for conductivity to increase when stage decreases due to ions becoming more concentrated and increasing the conductivity values.

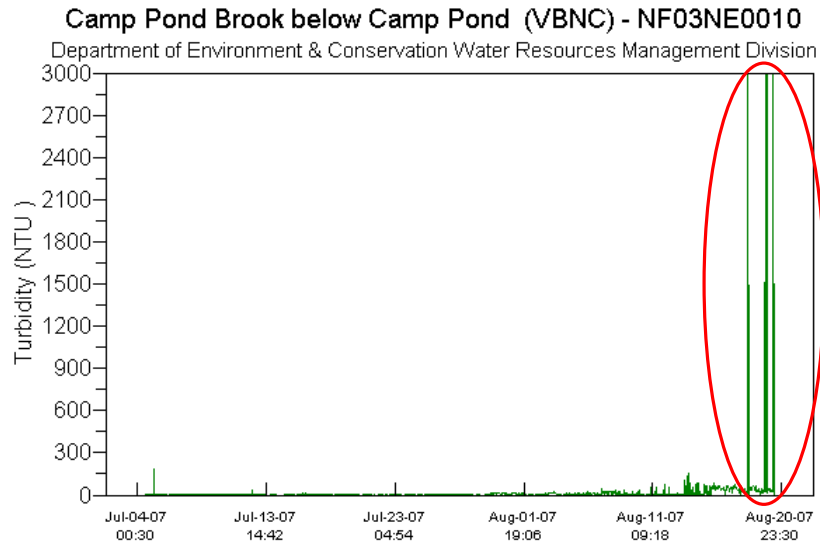
Figure 11

- The turbidity values (**Figure 11**) remained at fairly constant background levels for this station over the deployment period with the exception of one incident where turbidity values went to the instruments Hydrolab maximum of 3000 NTU. These spikes were seen at three different one-hour intervals and are likely due to erroneous readings due to the fact that occurred with one-hour time intervals and reached the maximum sensor reading of 3000 NTU.

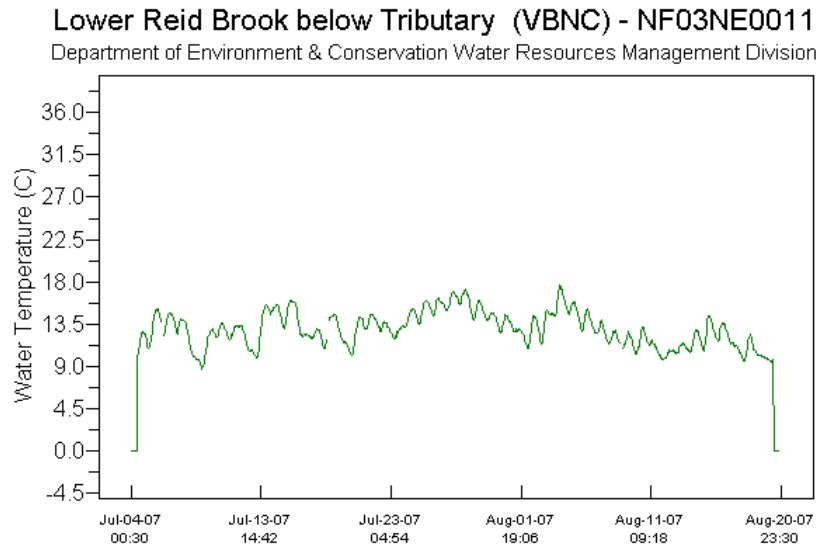
Figure 12

- The water temperature (**Figure 12**) showed an increase and then decreasing pattern throughout the deployment period. Corresponding, dissolved oxygen (**Figure 13**) showed a decrease and then increase throughout the deployment. This pattern is expected during the months of July and August.

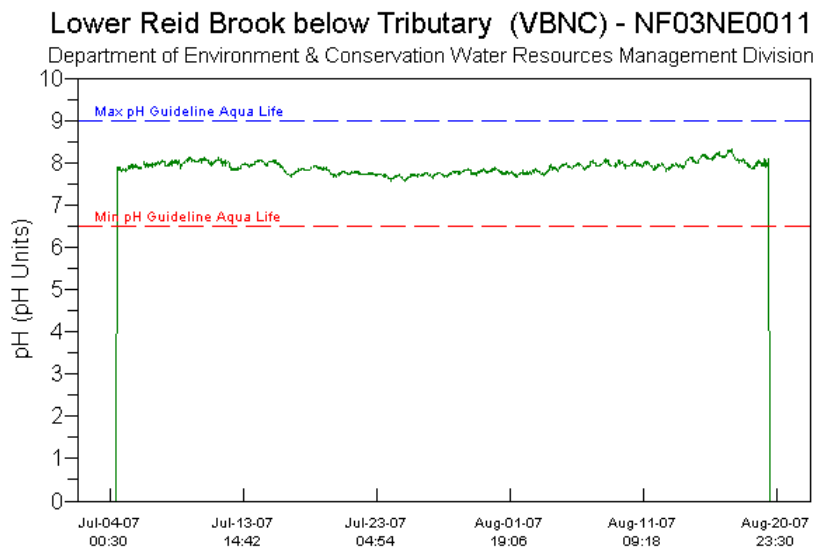
Figure 14

- pH (**Figure 14**) remained very consistent throughout the deployment period and within CCME Water Quality Guidelines for Aquatic Life (6.5 – 9.0).

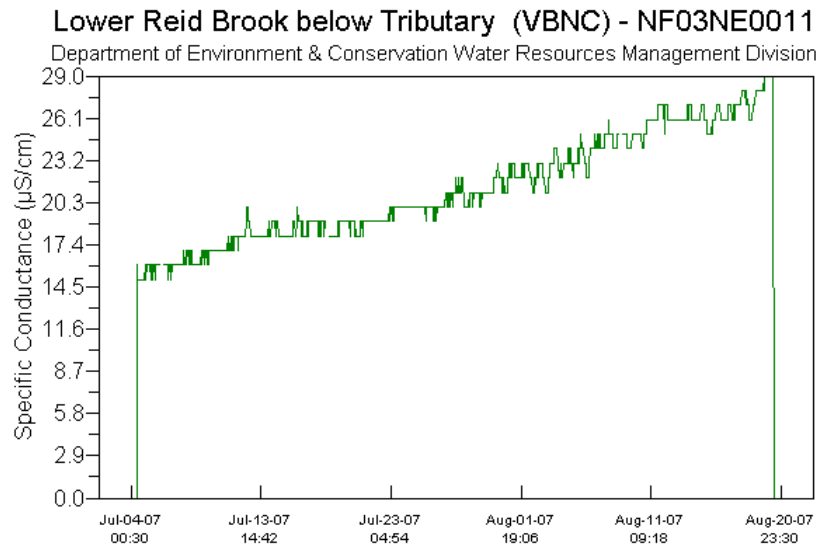
Figure 15

- The specific conductivity values (**Figure 15**) showed a slight increase throughout the deployment period. This is consistent with a slight decrease in stage (**Figure 16**) throughout the same period of time. It is typical for conductivity to increase when stage decreases due to ions becoming more concentrated and increasing the conductivity values.

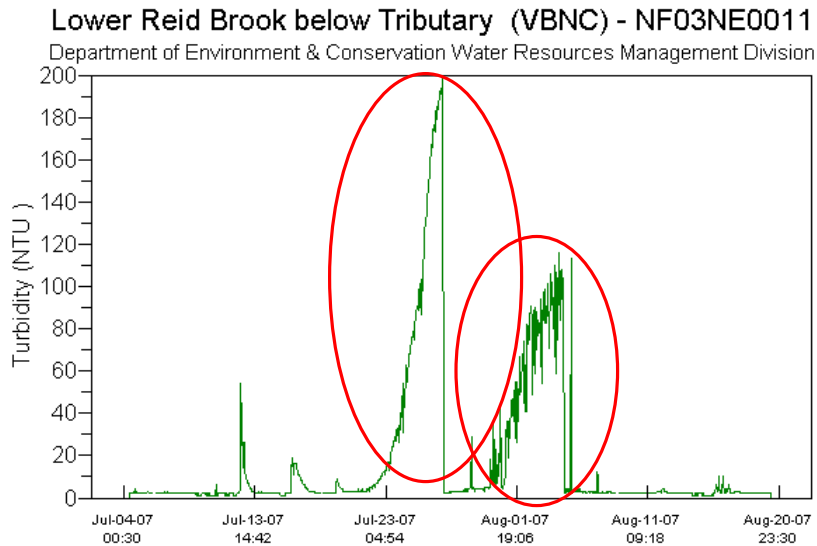
Figure 17

- Turbidity values (**Figure 17**) remained relatively stable with the exception of two incidents on July 23rd – 27th (maximum 200 NTU) and August 1st – 5th (maximum 116 NTU). Both incidences showed turbidity values increasing over a period of a couple of days and then decreasing to background levels over the period of a couple of hours. When the Hydrolab was removed by VBNC staff on August 20th, it was observed that there was significant evidence of disturbances in the sediment around the Hydrolab. This may have been the cause of the increased turbidity during the two incidences. A new deployment technique may have to be considered at this site. Turbidity values at this site will be examined to see if these type of occurrences are regularly seen at Lower Reid Brook.

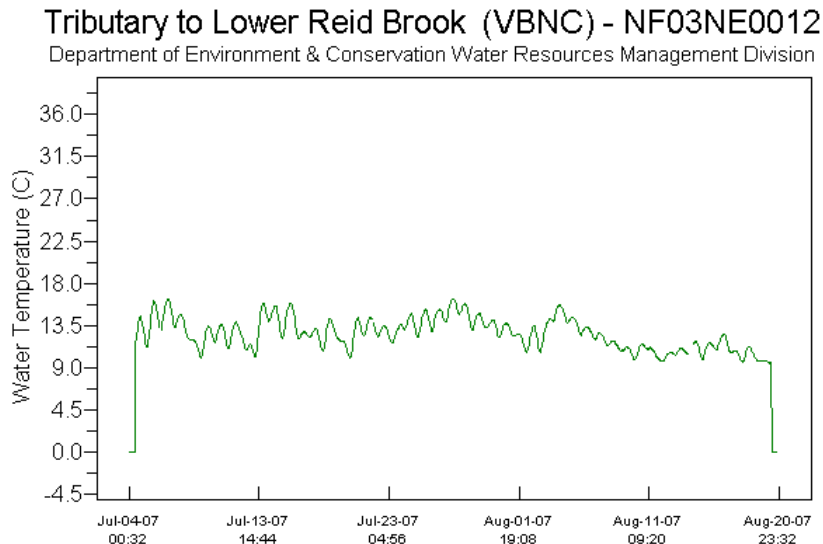
Figure 18

- Water temperature and dissolved oxygen (**Figures 18 & 19**) remained relatively stable during the deployment period of July to August.

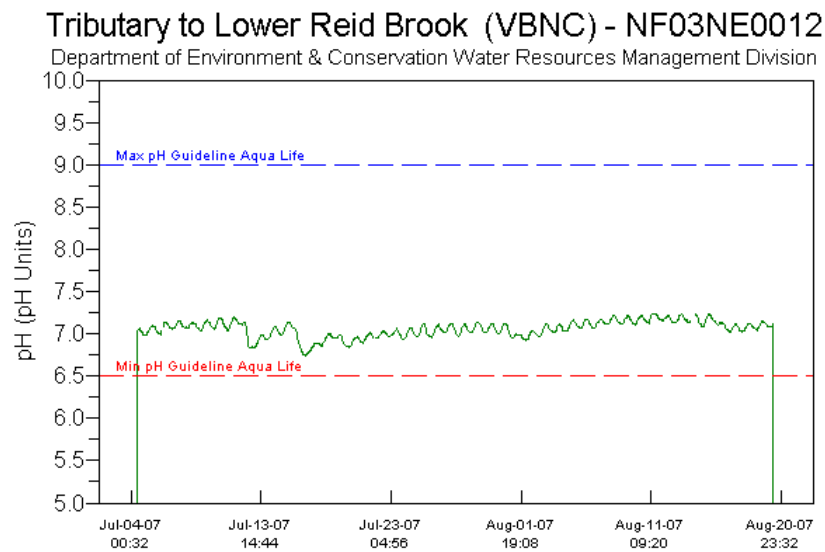
Figure 20

- The pH (Figure 20) remained at fairly constant background levels and within CCME Water Quality Guidelines for Aquatic Life (6.5 – 9.0) over the deployment period.

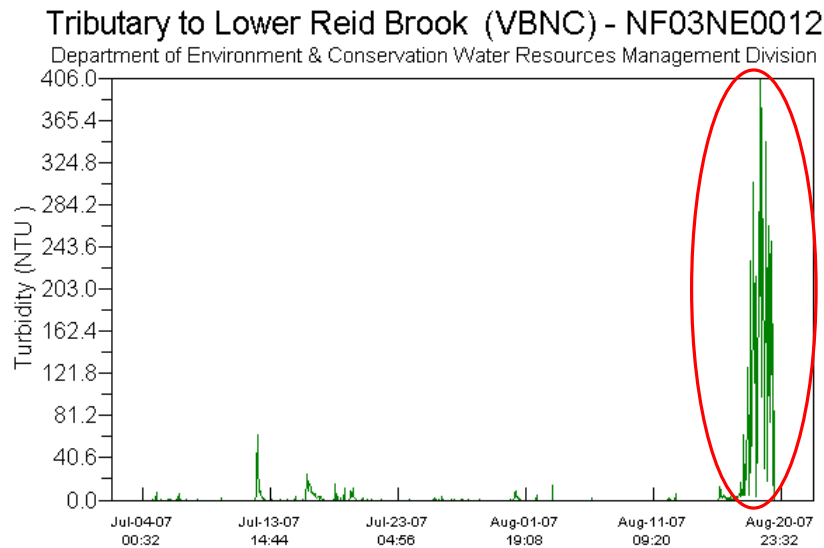
Figure 21

- Turbidity values (**Figure 21**) remained relatively stable throughout the deployment period with the exception of one incident which occurred August 18th – 20th. At this time it is unknown why this increase in turbidity occurred. Turbidity at this site will be closely examined to try and explain this occurrence.

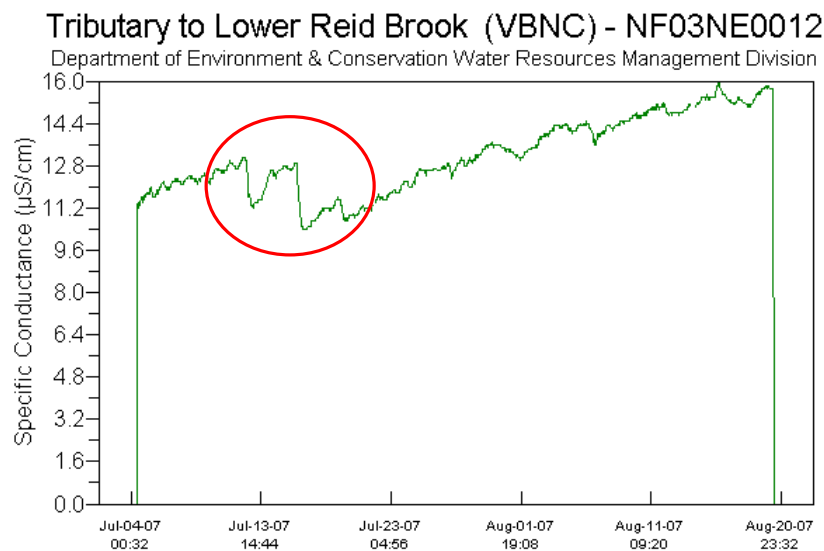
Figure 22

- The specific conductivity values (**Figure 22**) showed a slight increase throughout the deployment period. This is consistent with a slight decrease in stage (**Figure 23**) throughout the same period of time. It is typical for conductivity to increase when stage decreases due to ions becoming more concentrated and increasing the conductivity values. During the period of July 11th – 20th the conductivity fluctuated between 10.7 and 13.1. This was likely due to the two significant peaks in stage during the same time period. All conductivity values remained below 16uS/cm which is background levels for Tributary to Lower Reid Brook.
