Real Time Water Quality Monthly Report for Voisey's Bay Nickel Company Ltd. October 2003

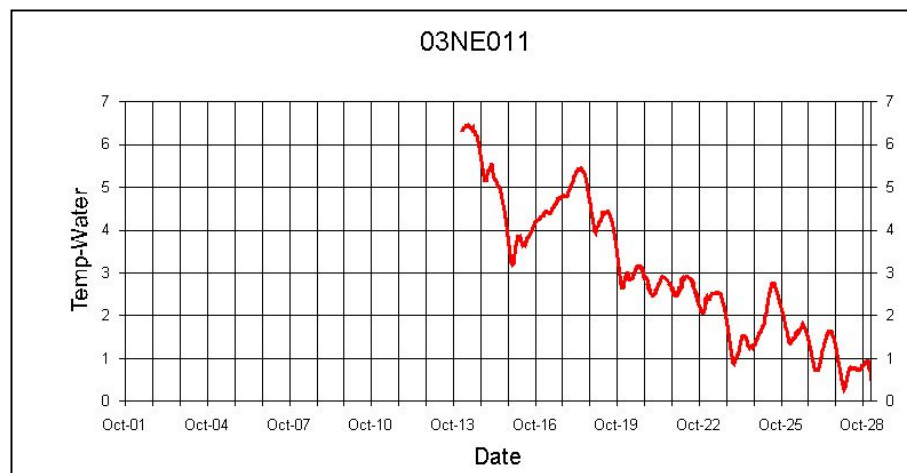
Figure 1

- Throughout the month of October most water quality parameters remained at expected background levels. However, it is important to note that the water temperature is quickly approaching freezing at all three locations. **Figure 1** clearly demonstrates this decrease in water temperature at Lower Reid Brook. The water temperatures and field conditions will be closely watched by Department of Environment staff and the VBN Environmental Officers (on-site) to determine exactly when the three Datasondes should be removed for the winter months.

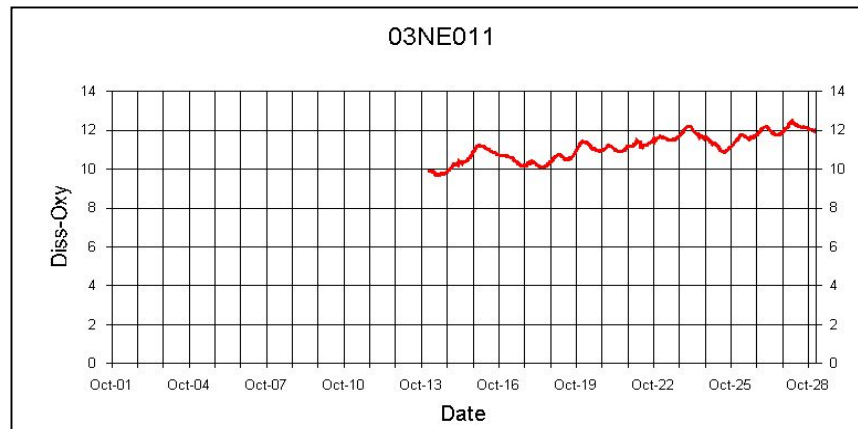
Figure 2

- With the decreasing water temperature there is an expected increase in the amount of oxygen being dissolved in the water as can be seen at Lower Reid Brook (**Figure 2**).

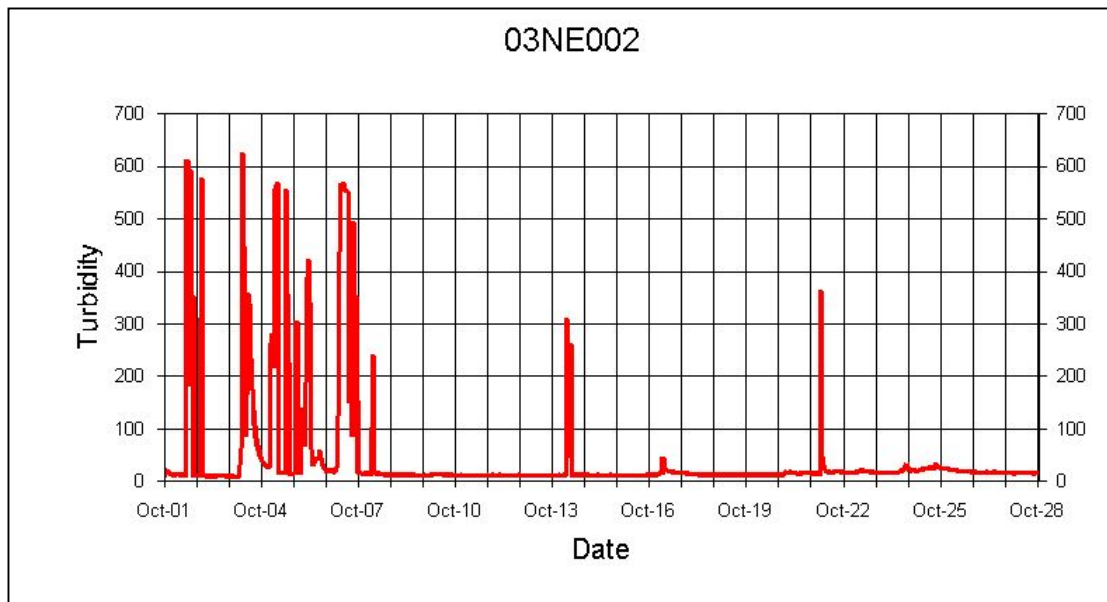
Figure 3

- There were a number of significant spikes in the turbidity levels in Camp Pond Brook below Camp Pond early in the month of October (**Figure 3**). However, the number of turbidity spikes decreased greatly throughout the remainder of the month. VBNC, SNC-Lavalin, and Aboriginal Environmental Monitors are continuously working with the construction contractor IKC-Borealis to improve upon sedimentation control strategies.

- Mitigation techniques to minimize sedimentation incidents in Camp Pond Brook are as follows:
 - a two-chambered sedimentation pond was constructed to receive turbid waters from excavations around the mill site and a french drain that collected surface water from the excavation of the south mill site area

- a three chambered settling pond was constructed at the east end of the mill site to control surface water runoff in that area during surface excavation and topsoil removal

- settling sumps have been constructed on the east and west sides of the Bailey Bridge to contain runoff from road surfaces near the bridge; both sumps have been lined with geotextile and maintained regularly

- hundreds of meters of silt fence have been installed parallel to Camp Pond Brook to create a filter barrier between mill site activity and the brook

- pumps ranging from 2" to 6" diameter discharge lines have been used for water diversion and discharge from the settling ponds
 - a six inch discharge line was placed from the 2-chambered settling basin to an area approximately 300 meters away from the brook where water from the settling ponds were released

- a permanent lined sedimentation pond - sed pond B (a component of water treatment during mine operation) was finished during October. After this time, all water required to be discharged from the sedimentation ponds has been diverted back to this lined pond

- IKCB have a team of field workers dedicated to maintain pumping systems and sedimentation ponds

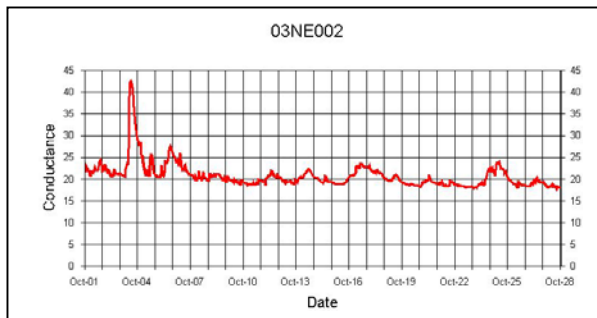
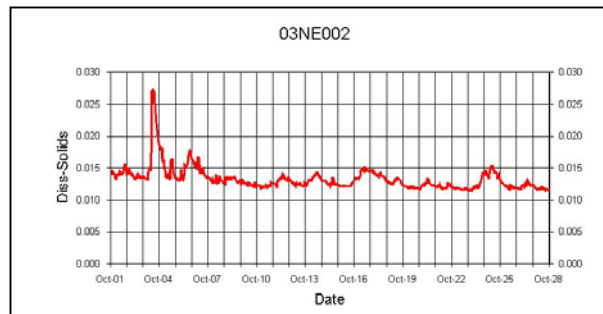
- As a result of the increased turbidity at Camp Pond Brook, other parameters such as conductivity and total dissolved solids also showed slight increases (**Figures 4 and 5**).

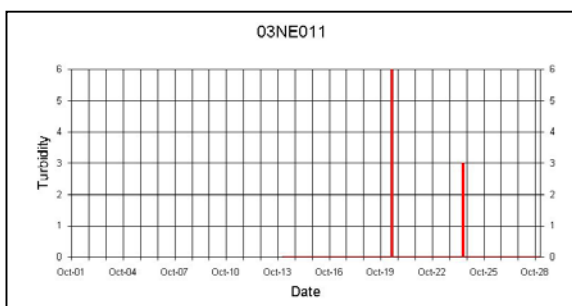
Figure 6

- The turbidity values at the Lower Reid Brook site remained very low throughout the month of October. It only strayed from the background value of 0 NTU on two occasions. The first was on October 19th (6 NTU) and the second was on October 23rd (3 NTU) (**Figure 6**). It is important to note that the stage had also increased around these times indicating heavy rainfall events influenced the slight increases in turbidity (**Figure 7**). The turbidity values at the Upper Reid Brook site also remained very low only ranging from 0 – 3NTU throughout the month of October.
