- Department of Environment and Conservation staff monitors the real-time web pages consistently.
- This monthly deployment report interprets the data from Rattling Brook Big Pond, Rattling Brook below Bridge and Rattling Brook below Plant Discharge stations for the period of November 18, 2009 to December 15, 2009.

### *RATTLING BROOK BIG POND*

*RATTLING BROOK BELOW BRIDGE*

### RATTLING BROOK BELOW PLANT DISCHARGE

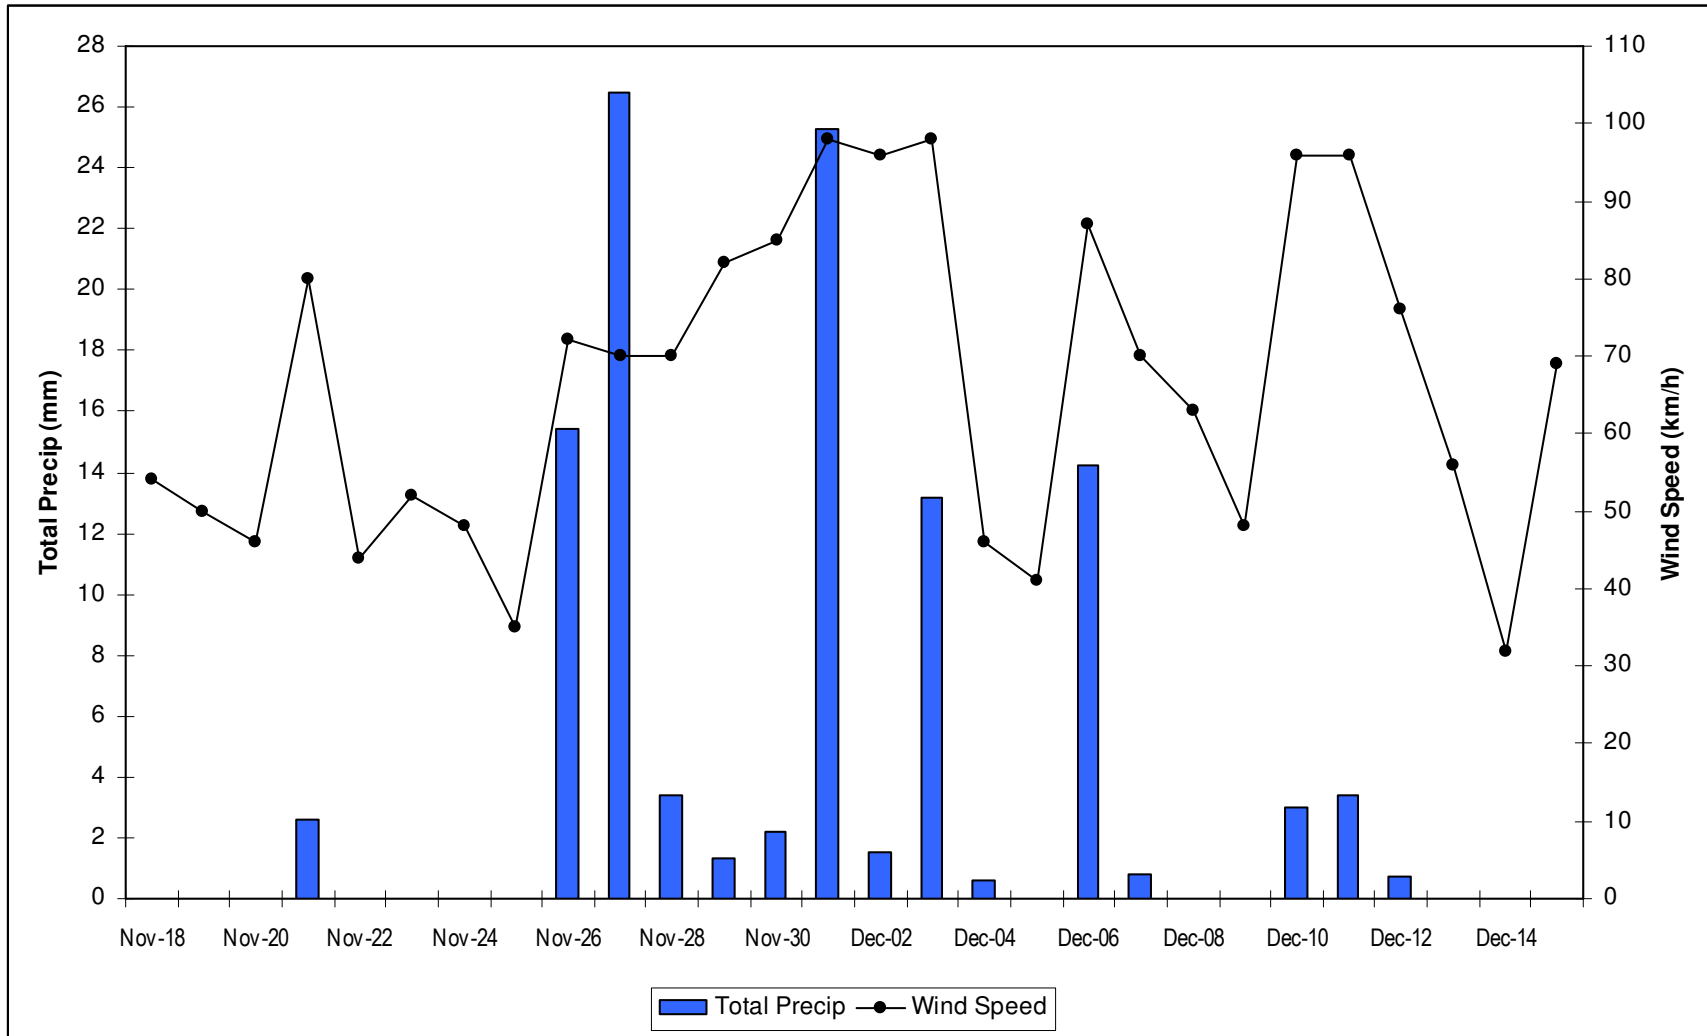
**Figure 19: Total Precipitation and Wind Speed at the Argentinia Weather Station, new Long Harbour**

- Conductivity at Rattling Brook below Bridge ranged from 33.9 to 40.9  $\mu\text{S}/\text{cm}$  during the deployment period. Two peaks indicated on the graph above are associated with heavy precipitation of about 42 mm on November 26<sup>th</sup> and 27<sup>th</sup>, and 26 mm on December 1<sup>st</sup> resulting in runoff into the river system. Another precipitation event on December 6<sup>th</sup> caused a decline in conductivity as opposed to a spike due to air temperature at the time. Precipitation between December 5<sup>th</sup> and 9<sup>th</sup> fell as snow, causing little to no runoff, leading to a dilution effect in the river.
